CK-2208

MOWHOKAM 16.3km

2014 Inspection

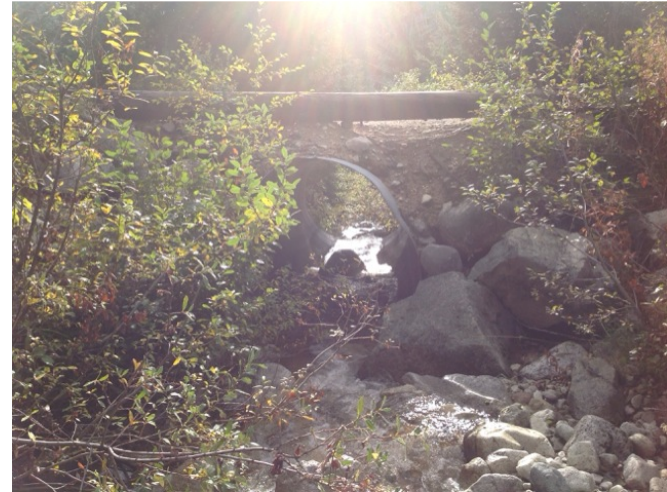
Inlet Fair

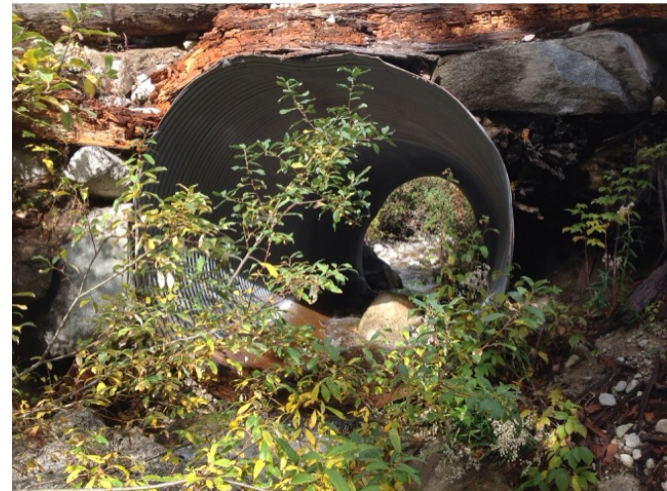
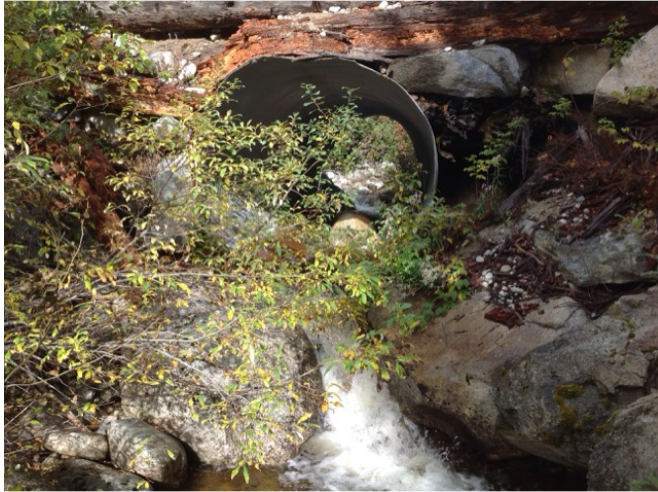
Outlet Fair some scour

| 1 | monitor the condition of the culvert (deformation), culvert infill and scour noted at the outlet |

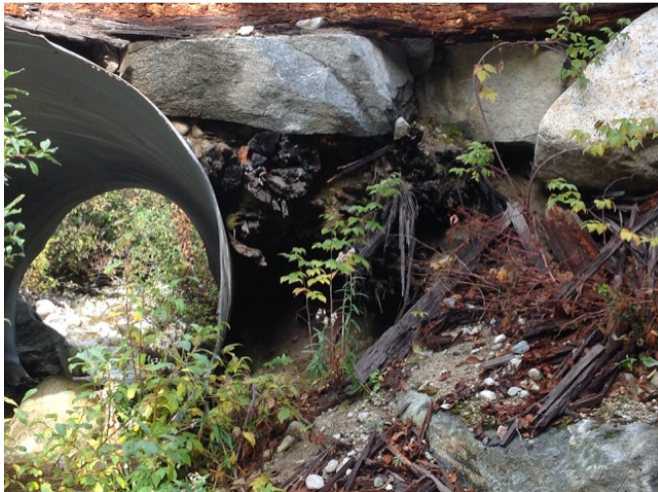
Fill Fair erosion of running width both upstream and downstream - logs used as backfill left approach are rotting, logs used for fill fill retention rotting

logs as backfill

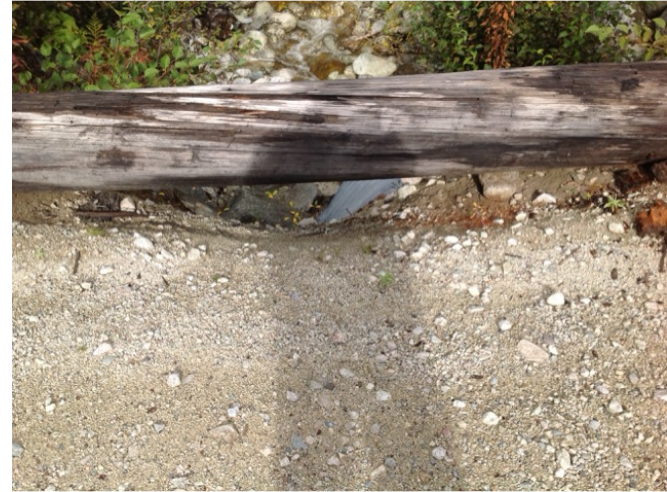
erosion upstream

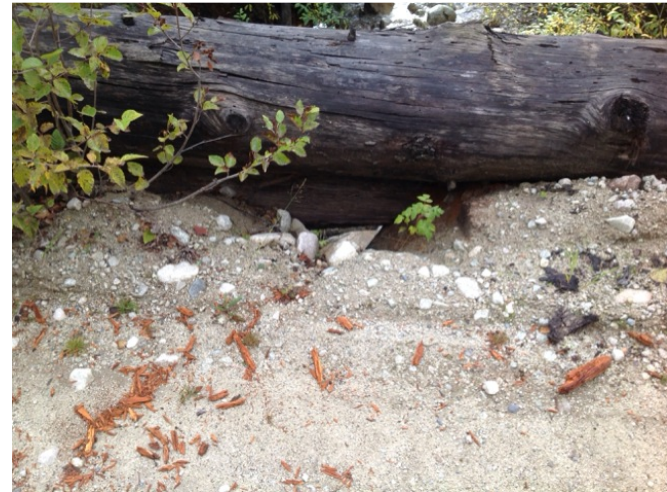
erosion downstream
