CK-2214

PEERS CREEK 0.3km

2014 Inspection

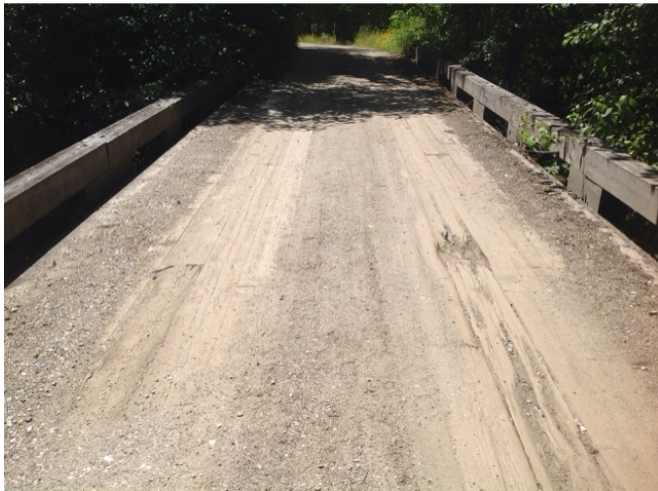
Deck

Running Planks Fair some rotting sections on wheel path

Brush and grade approaches, replace missing delineators and bridge ahead signs. Running planks are showing signs of wear, recommend replacing prior to industrial use. Present load rating of L60 or 54 tonnes to continue.

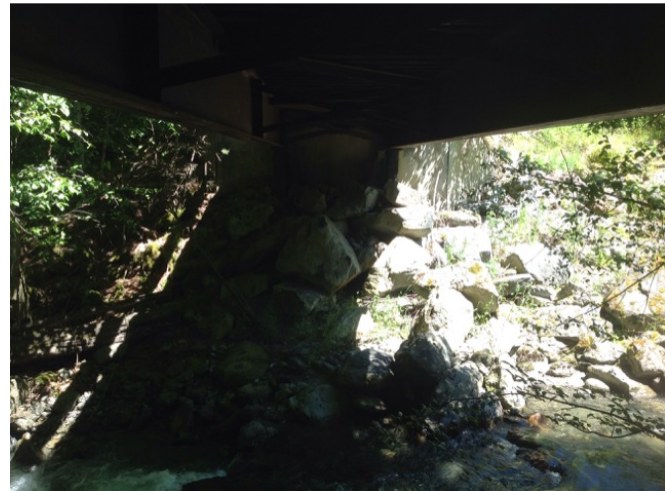
Right Bank Abutment when facing downstream

Ballast Wall Fair hairline cracks, does not appear to be spreading from last inspection

Hardware Fair only single bay of bracing on pipe towers - very steep angle
