CK-2217

PITT RIVER 2.2km

2014 Inspection

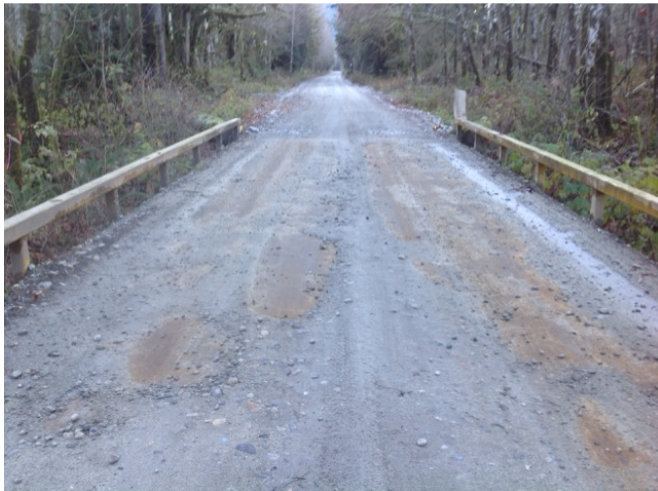
Steel Deck Plate Fair anti skid all but worm off, some deformation of deck

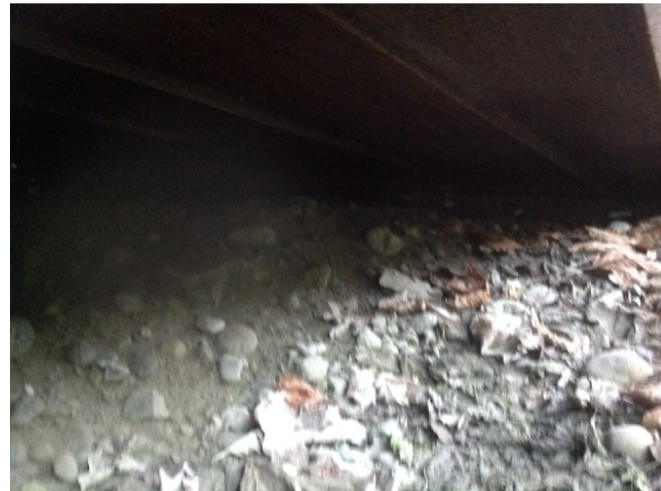
Left Bank Abutment when facing downstream

Caps or Sills Unrated cannot access to properly assess - does not appear to be crushing even with localized mycelium
