CK-2220

PITT RIVER 12.1km

2014 Inspection

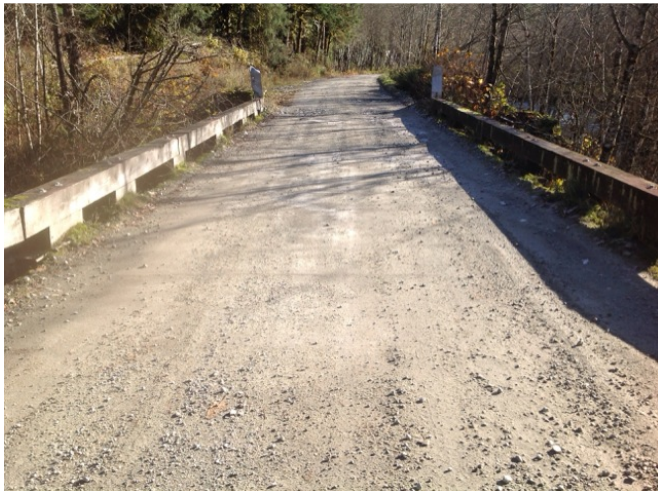
Curb Rail/Blocks/Posts Poor rotten risers and blocks

Overall Deck Condition Poor due to rotten risers and blocks

| Repair Item | Priority | Repair Description |
|---|---|---|
| 2 | Medium | replace guardrail, risers and blocks |

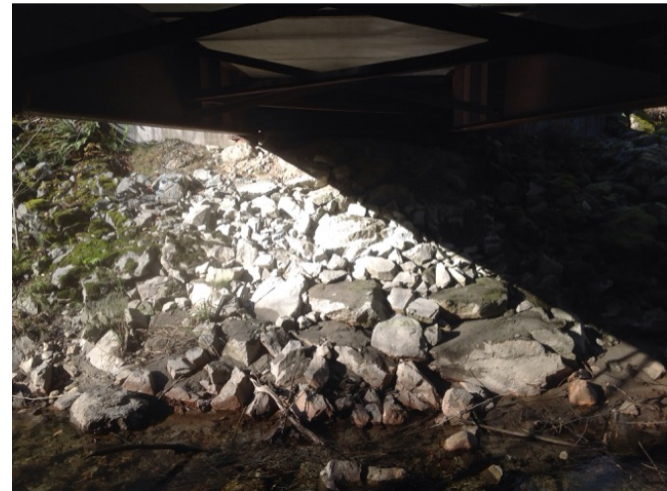
Right Bank Abutment when facing downstream

Bearings Fair bulging upstream right
