CK-2222

PITT RIVER 18.2km

2014 Inspection

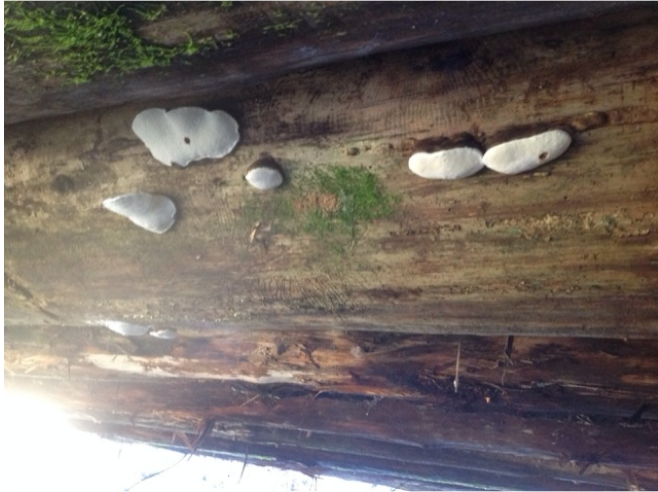
| Stringer<br>Number | Species | Peeled | Diameter<br>(mm) | Rot Depth<br>(mm) | Comment |
|---|---|---|---|---|---|
| 8 | Fd | Y | 650 | 120 | conks noted |

conk on stringer 8
