CK-2224

PITT RIVER 23km

2014 Inspection

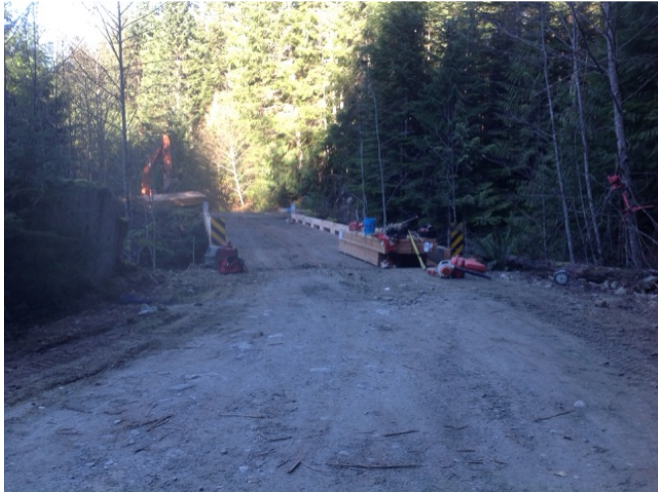
Approach from Left Bank when facing downstream

HC both approaches

Bridge Ahead Signs  
Missing ☐ 0 ☐ 1 ☒ 2

Post bridge ahead signs. L100 or 91 tonnes load rating.

| 1 | Medium | bridge ahead signs |

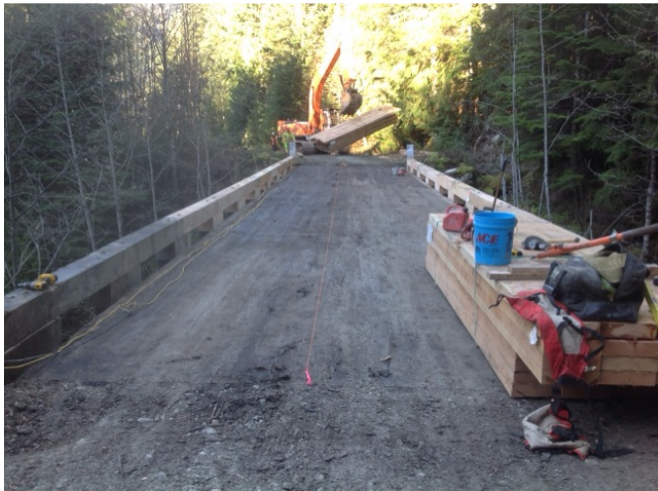
Running Planks Good just replacing them now

Overall Deck Condition Good

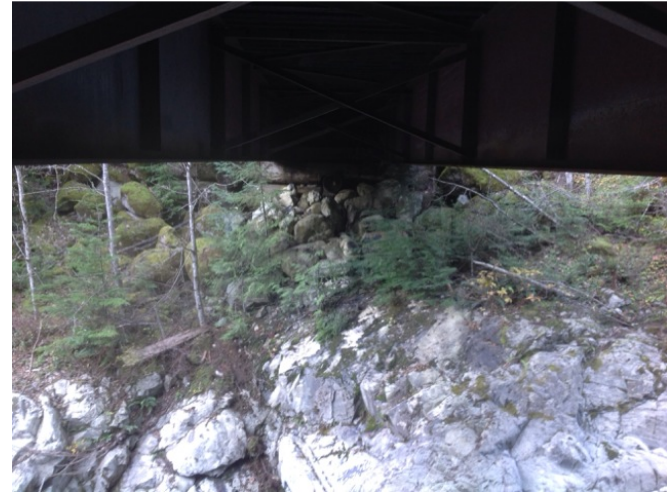
Right Bank Abutment when facing downstream

Log/Timber Cribs Fair
