CK-2225

PITT RIVER 24.6km

2014 Inspection

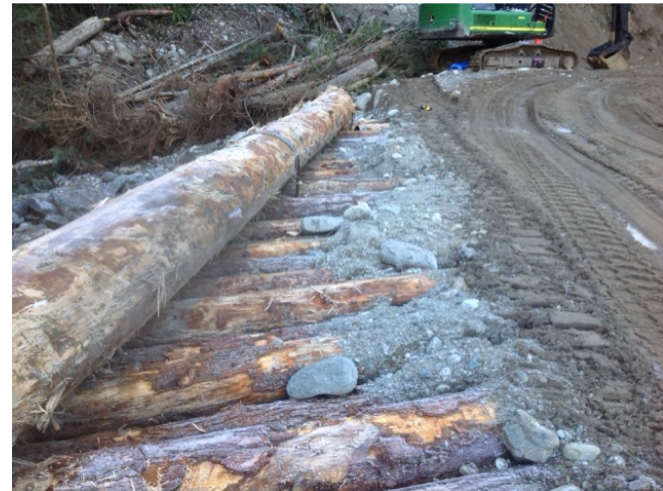
bridge is on skew  
14.4m span upstream and 14.8m span on downstream  
deck is a combination of puncheon and gravel - average 300mm thick

puncheon and gravel deck
