## Permanent Bridge Inspection Report

| Structure #: | CK-2226 | Site #: | CK-2226 | Road Name: | PITT-BOISE | Inspection Date: | 2014/11/12 |
| KM: | 0.30 | User km: | 0.30 | Crossing Name: | Pitt River | Next Inspection Date: | 2017/11/12 |

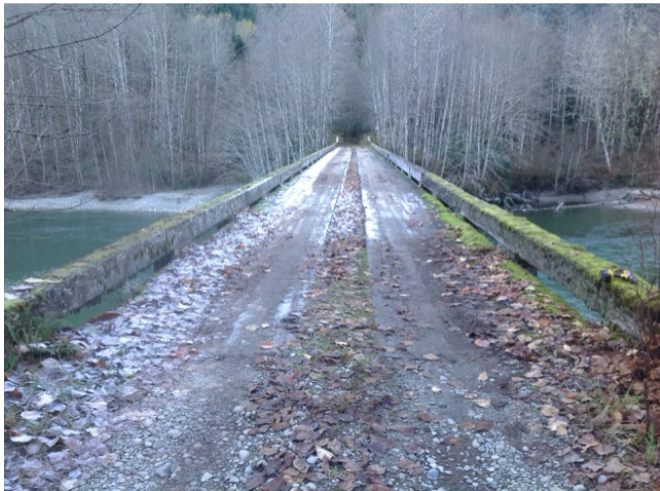
| Nails | Poor | running plank nails protruding | | | | | |
| Overall Deck Condition | Poor | due to running planks and rail condition | | | | | |
| Running Planks | Poor | rotten | | | | | |

| | 1 | Required | High | \$1.00 | Replace running planks | | | | | | |
| | 2 | Required | High | \$1.00 | replace guardrail and risers | | | | | | |
