CK-2227

PITT-BOISE 2km

2014 Inspection

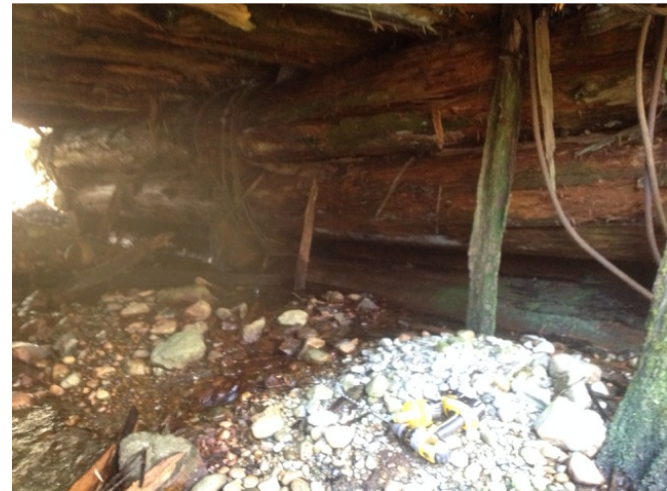
Left Bank Abutment when facing downstream

Log/Timber Cribs Poor top crib log on left side cracked horizontally

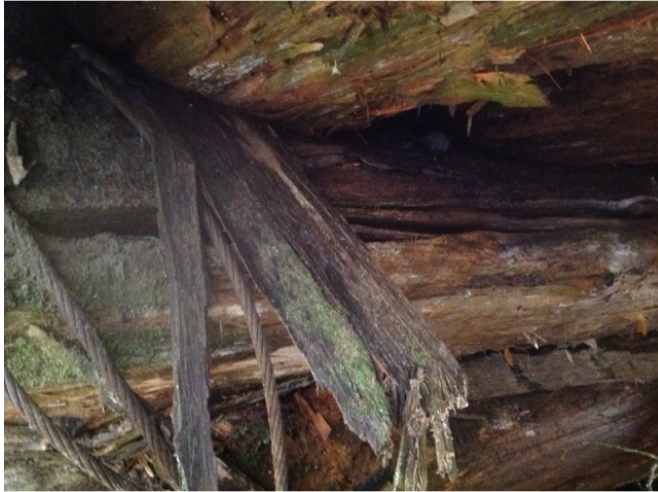
top crib log on left crib

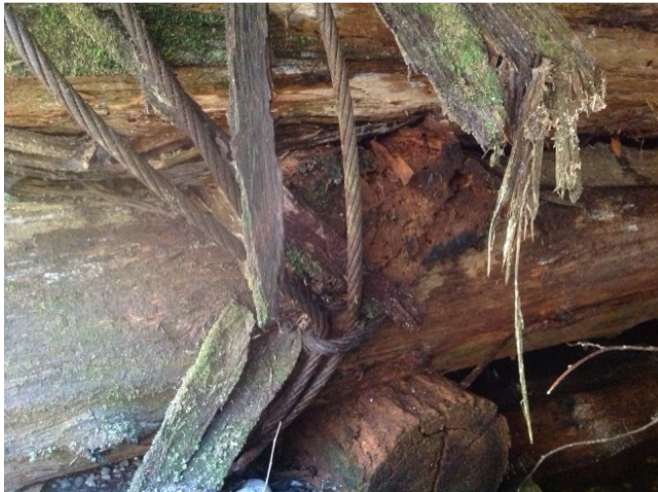
Tie Backs Poor rotten

typical tie back

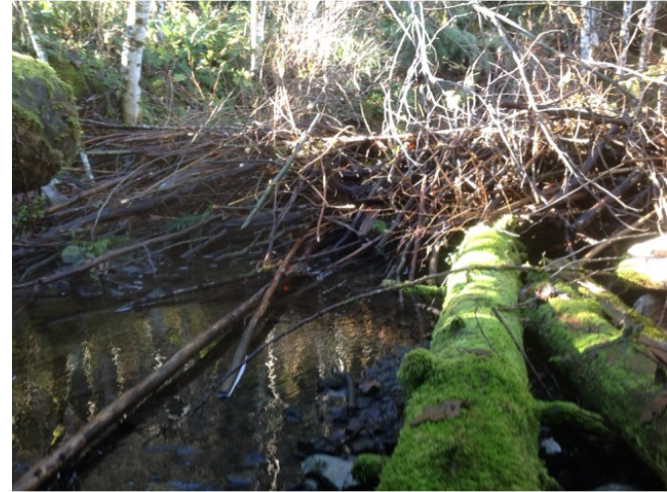
Comments beaver dam immediately upstream

beaver dam
