CK-2228

PITT-BOISE 3.2km

2014 Inspection

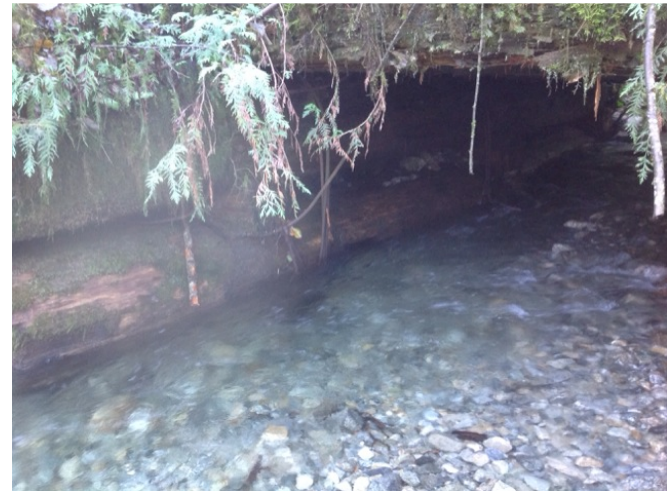
Right Bank Abutment when facing downstream

Bearings Poor scoured under downstream right crib
