## Log Stringer Bridge Inspection Report

| Structure #: | CK-2232 | Site #: | CK-2232 | Road Name: | PITT-BUCKLIN | Inspection Date: | 2014/11/12 |
| KM: | 3.00 | User km: | 3.00 | Crossing Name: | Bucklin Creek | Next Inspection Date: | 2016/11/12 |

2014 Inspection

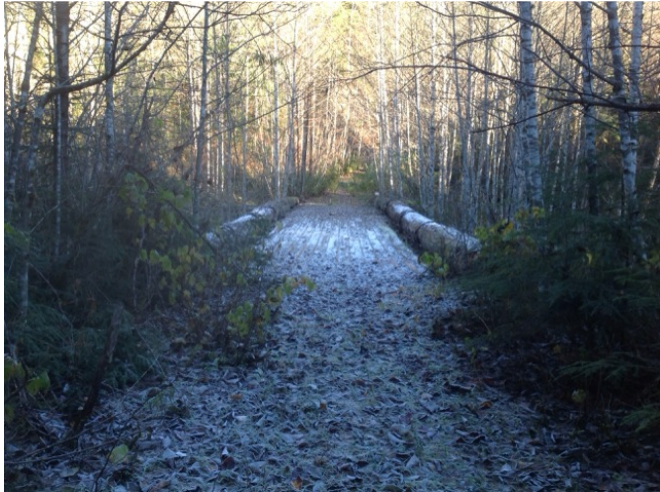
Approach from Right Bank when facing downstream

| Road Surface | Poor | grown over but most likely pickup accessible |

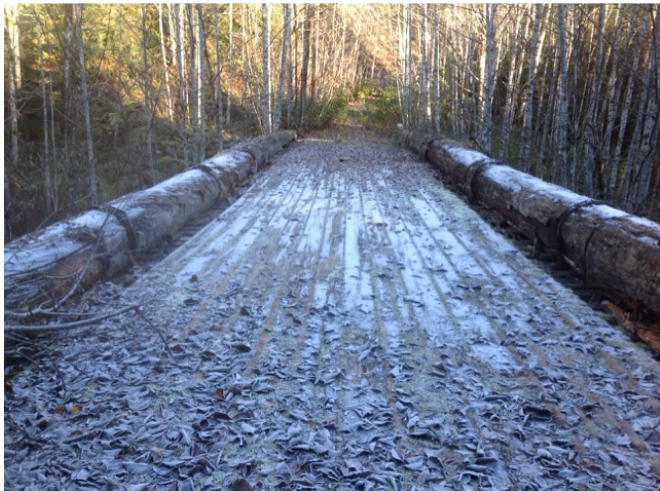
| Curb Rail/Blocks/Posts | Poor | rotten |
| Nails | Poor | protruding |
| Overall Deck Condition | Poor | rotten |
| Sub Deck | Poor | rotten |
| Ties | Poor | rotten |

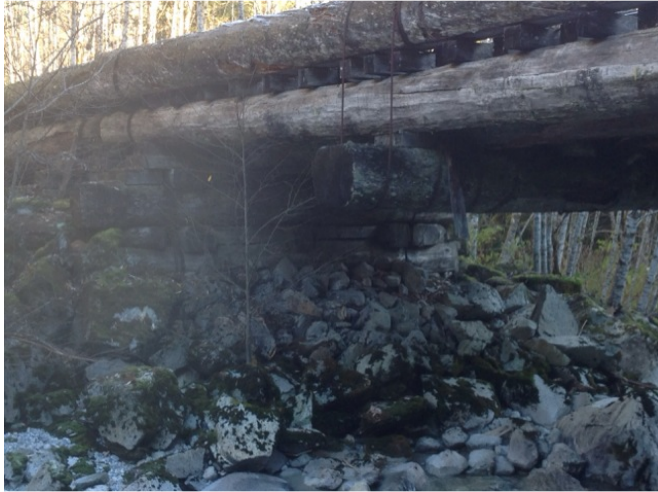
right pier crib

| Cribs | Fair | closed face Cw crib |

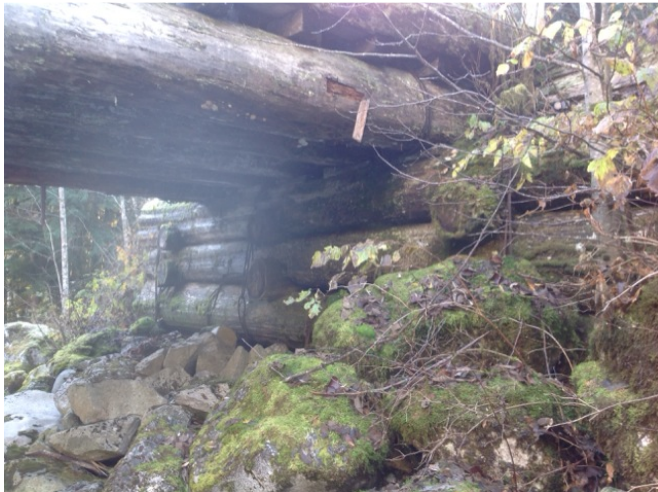
Right Bank Abutment when facing downstream

| Hardware | Poor | loose lashing |
| Log/Timber Crib | Fair | Cw crib right bank, single Cw sill left bank |

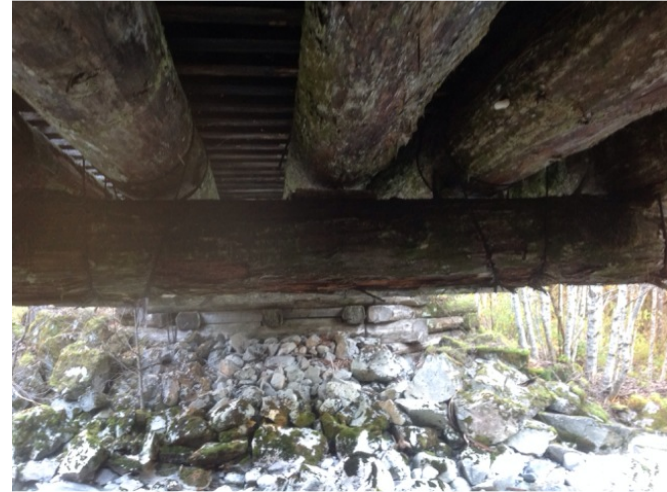
first span stringers

| Log Curbs | Poor | rotten | | | | | | | | | |

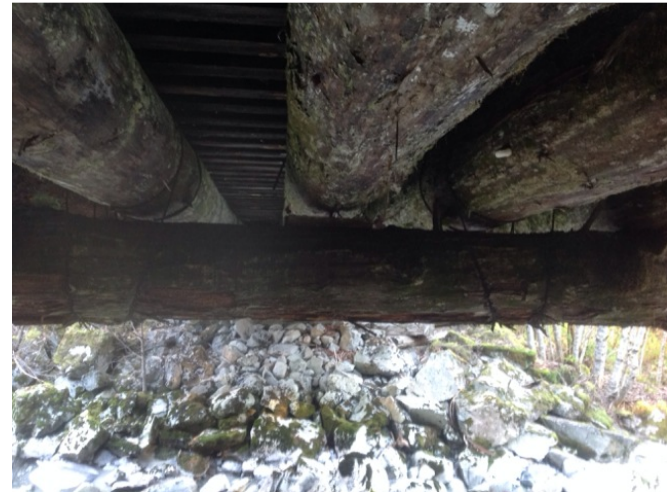
| Needle Beam(s) and Shims | Poor | loose | | | | | | | | | |

first span loose needle beam

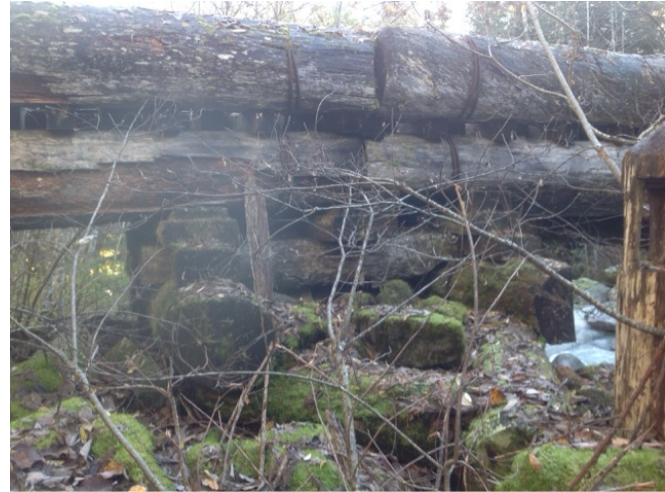
pier

| Overall | Fair | |

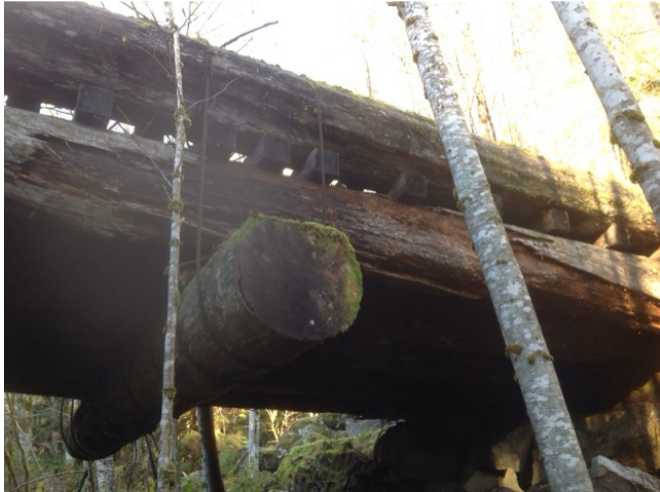
| GENERAL | Inspector's Comment: | Bridge condemned. Ensure access is blocked and structure posted. Remove entire structure or monitor for failure. | | | | | | | | | |

typical stringer condition

| | 1 | Required | High | \$1.00 | block access | | | | | | |
