CK-2236

SOWAQUA CREEK 9.6km

2014 Inspection

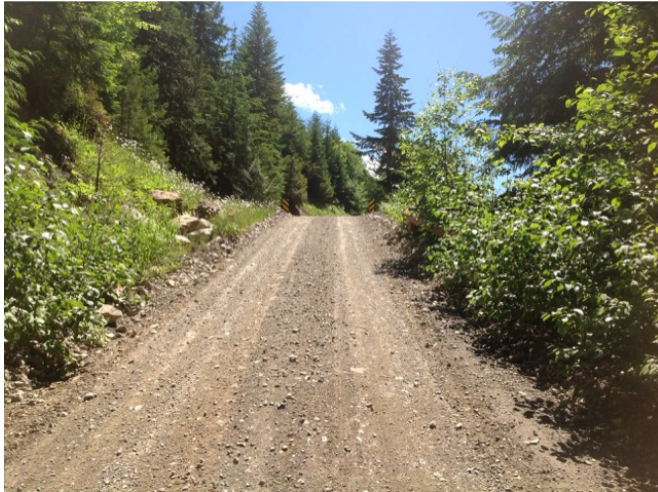
Approach from Right Bank when facing downstream

rocks left approach, missing upstream right

Post bridge ahead signs, replace missing fender logs. Monitor for steel deformation as bearing plates only partially on log sills.

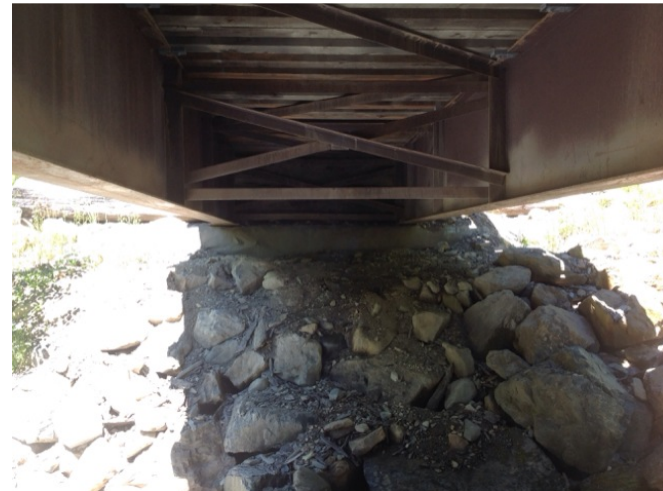
Right Bank Abutment when facing downstream

single log sill

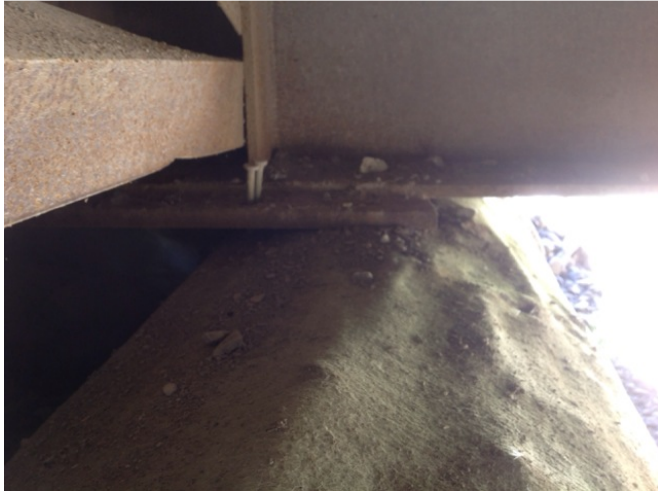
bearing plates not completely on sills and loosely fastened

left downstream bearing

| 1 | monitor steel deformation as bearing plates only partially on sills |

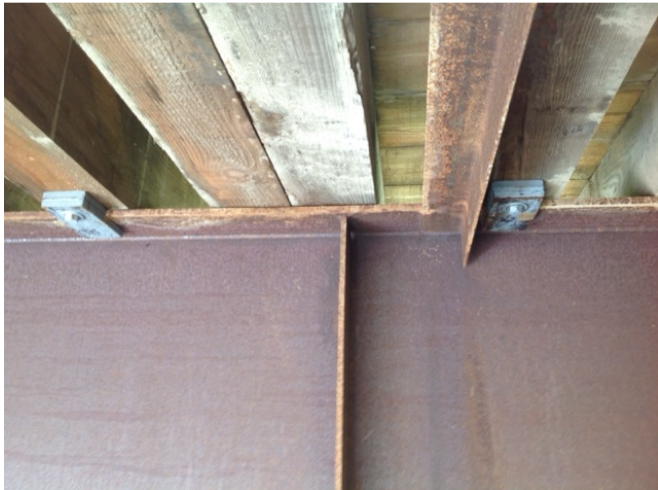
Deck to Girder Bolts Good modular clips

deck clips

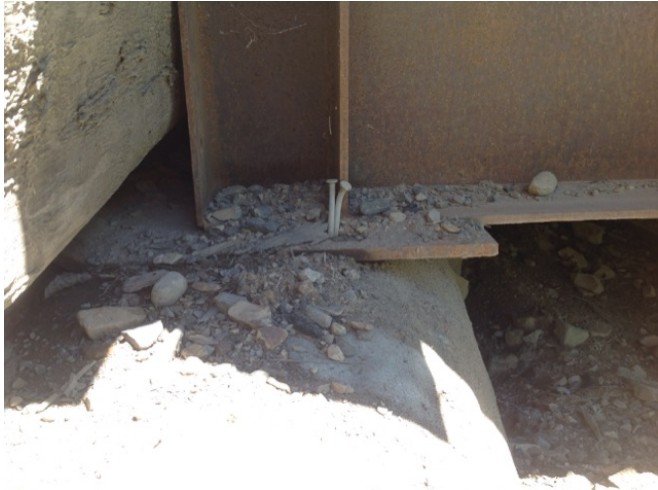
right down stream bearing
