CK-2237

SOWAQUA CREEK 14.6km

2014 Inspection

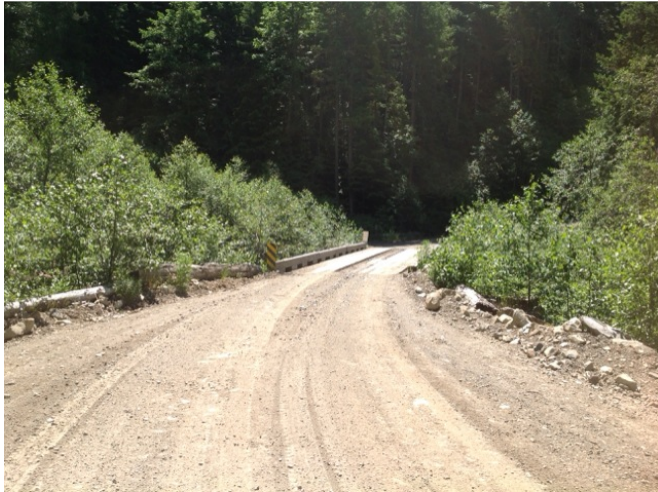
Approach from Right Bank when facing downstream

Bridge Ahead Signs  
Missing ☐ 0 ☐ 1 ☒ 2

| Repair Item | Priority | Repair Description |
|---|---|---|
| 2 | Medium | post bridge ahead signs |

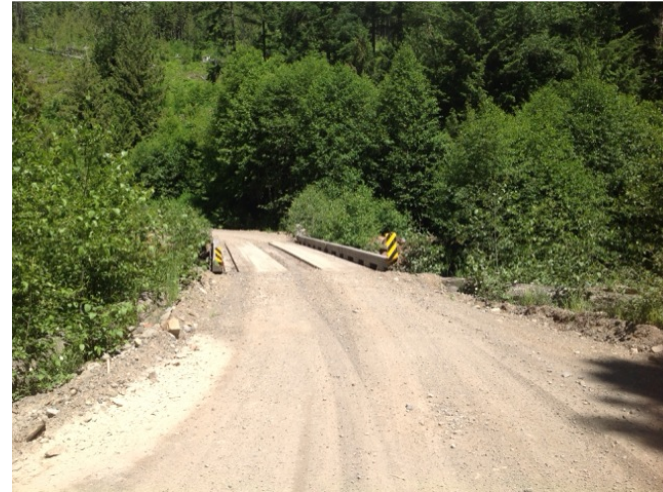
Approach from Left Bank when facing downstream

Delineator Missing  
Left ☒ 0 ☐ 1 ☐ 2Delineator Missing  
Right ☐ 0 ☒ 1 ☐ 2

| Repair Item | Priority | Repair Description |
|---|---|---|
| 1 | Medium | replace missing delineator |

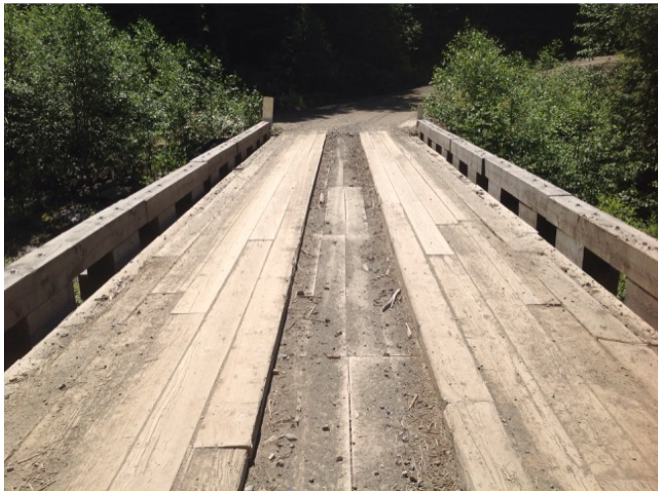
Overall Deck Condition Fair

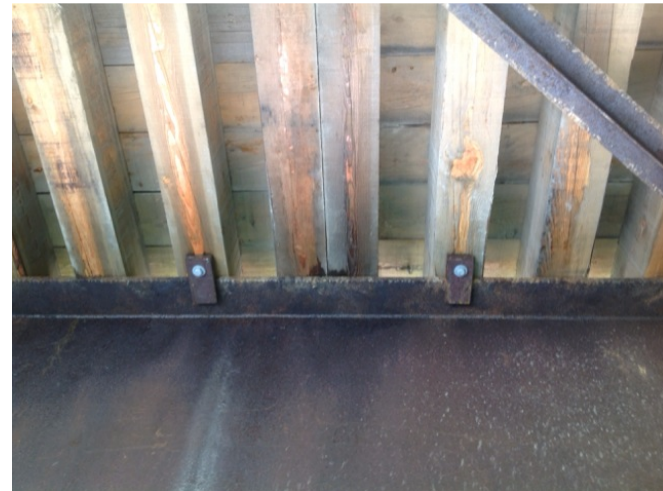
deck clips

Deck to Girder Bolts Fair modular clips

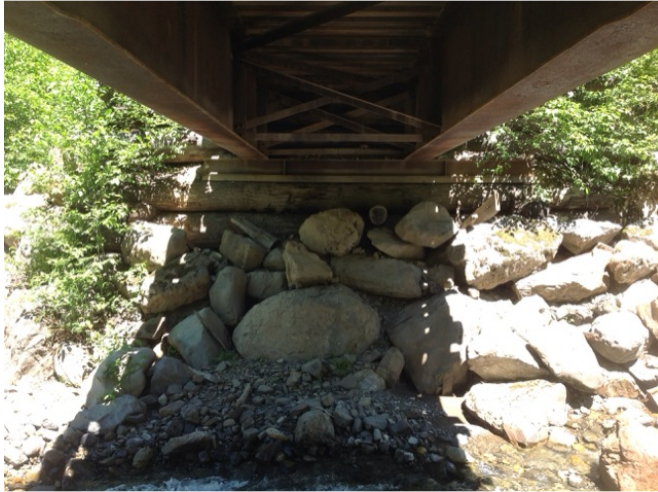
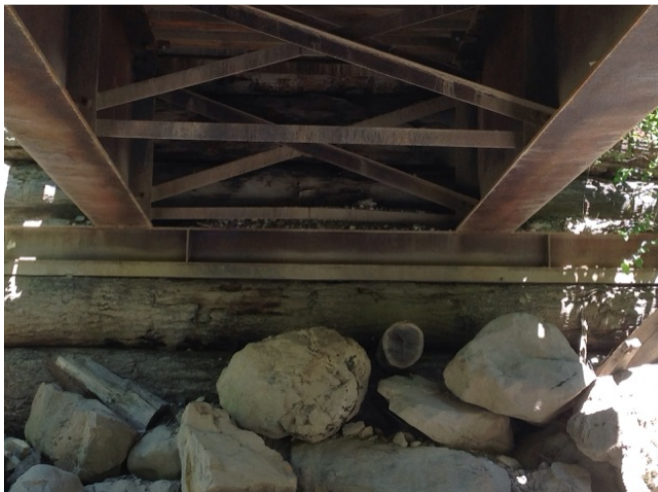
Right Bank Abutment when facing downstream

Log/Timber Cribs Fair 2x, Fd but not peeled

Tie Backs Fair 3x, small and unpeeled

Caps or Sills Poor

steel cap not centred under girders (not ~~on~~ set stiffeners) and only held in place with 2 nails

Replace missing delineator and post bridge ahead signs. Monitor abutment condition annually. The girders appear to be only 1 section of a 30.480m o/o length as indicated on the steel.

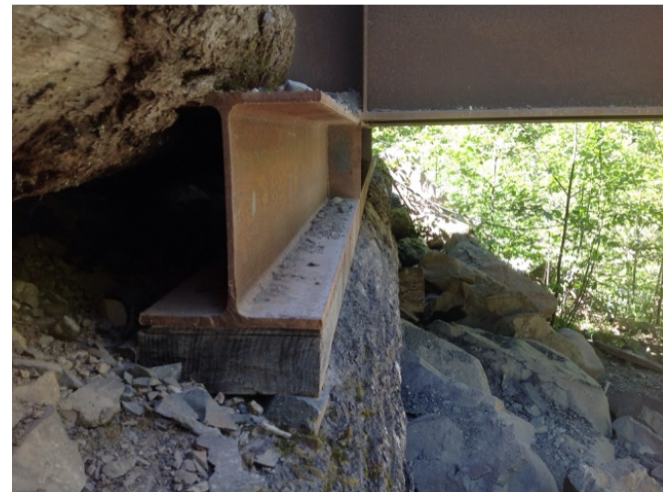
left bank upstream bearing

Hardware Fair only nails holding steel cap onto timber sill

Bearings Fair girders off Center on steel cap

1 bearings
