CK-2248

SPUZZUM SEVEN 0.2km

2014 Inspection

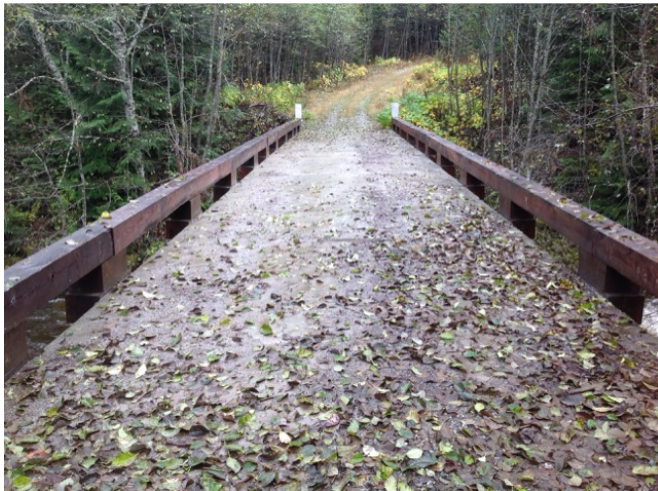
Overall Deck Condition Fair
