## Log Stringer Bridge Inspection Report

| Structure #: | CK-2261 | Site #: | CK-2261 | Road Name: | STAVE RIVER | Inspection Date: | 2014/12/02 |
| KM: | 8.50 | User km: | 8.50 | Crossing Name: | Winslow Creek | Next Inspection Date: | 2015/12/02 |

STAVE RIVER 8.5km

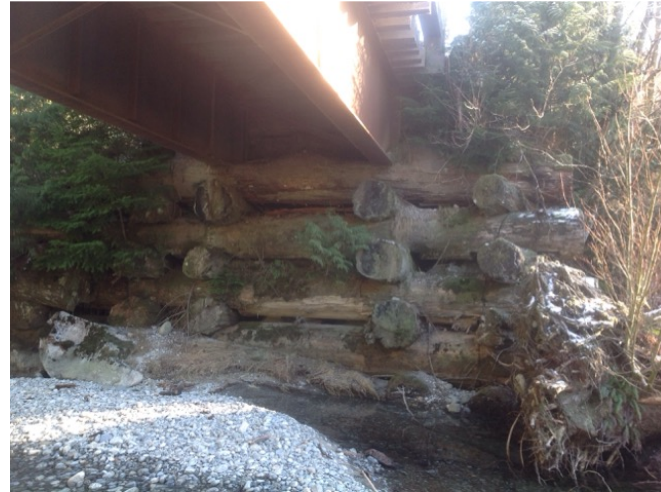
| Log/Timber Crib | Poor | 4x left, 5x right - top crib logs are rotting |

Left Bank Abutment when facing downstream

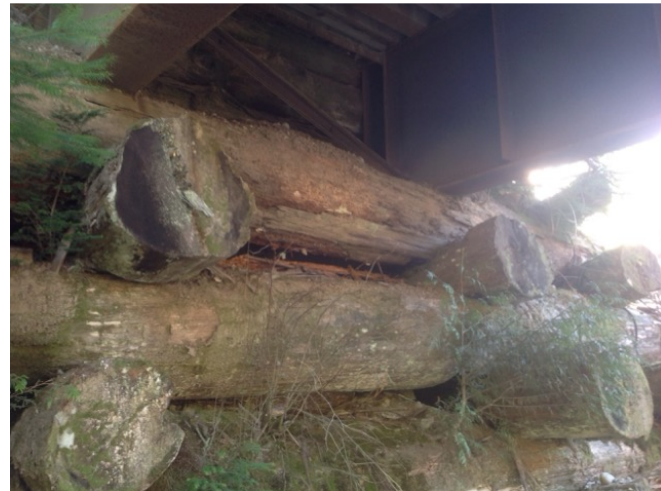
| GENERAL | Inspector's Comment: | The top crib logs on the abutments and pier are in poor shape (rotting and crushing). Present load rating of 30 tonnes to continue. Monitor debris accumulations at the inlet. | | | | | |

top crib log on left abutment

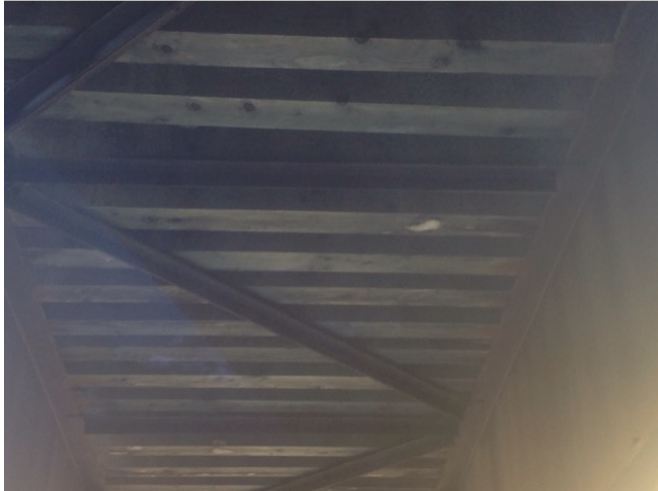
| Ties | Fair | 200mm x 300mm - some are showing signs of rot |

some ties in fair to poor shape

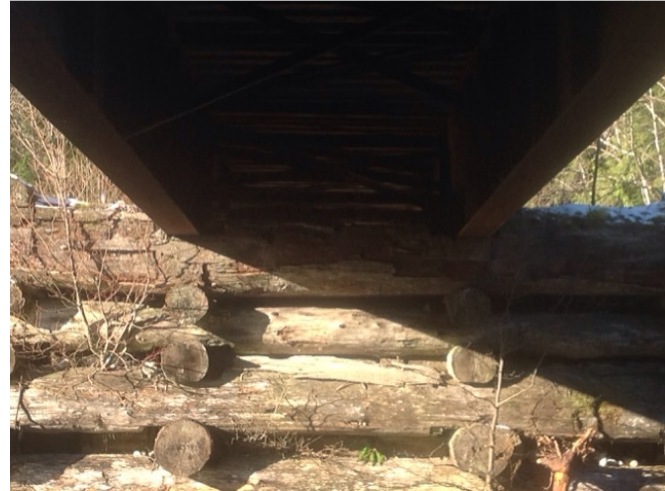
| Caps | Poor | rotting and crushing logs |
| Overall | Poor | top logs especially in poor shape |

top crib log of pier, on left side in poor shape

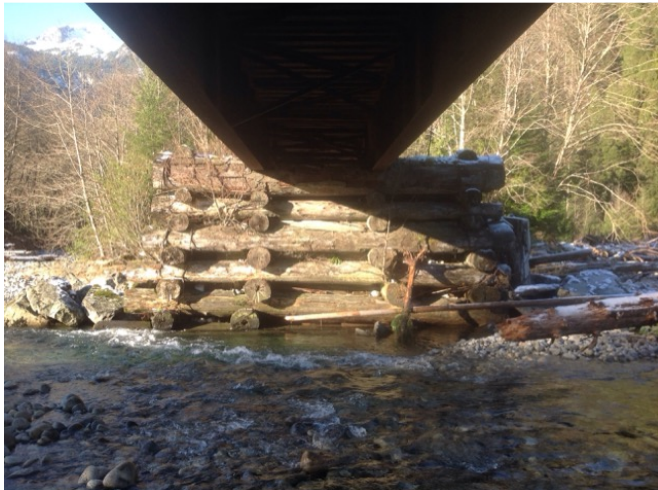
pier

| Cribs | Poor | 5x - and rotting |

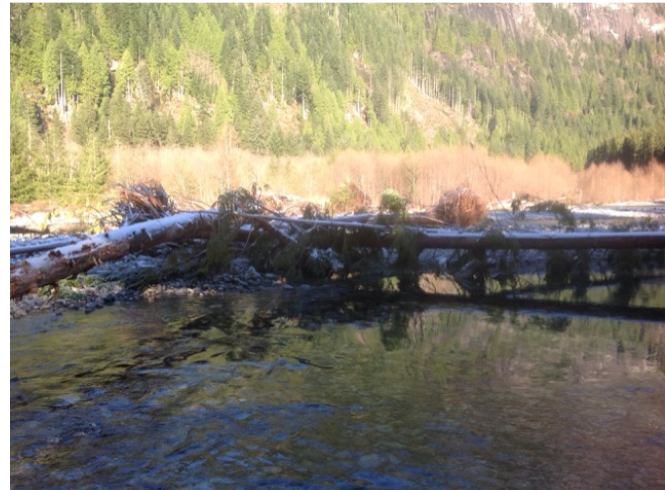
| | 1 | Debris accumulations at inlet |

debris at inlet

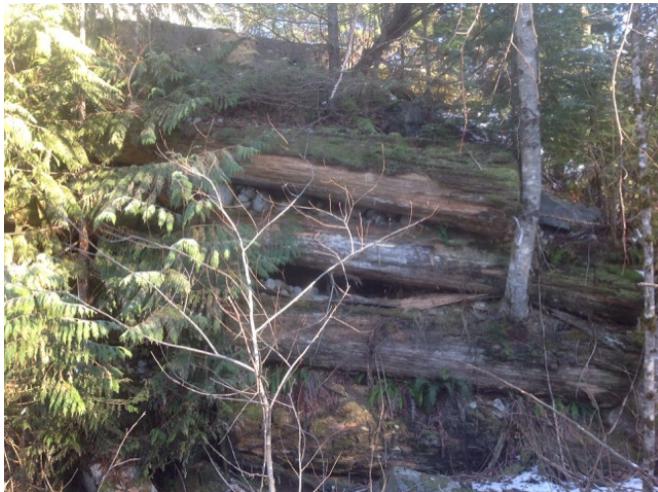
| Wing Wall | Poor | only left abutment and slumping |

wing wall left approach downstream

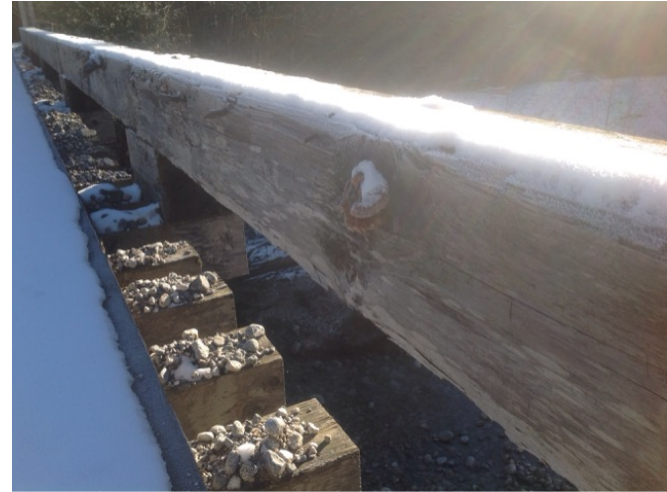
| Curb Rail/Blocks/Posts | Fair | some risers and guardrail in poor shape - some must have been replaced |

conk on guardrail

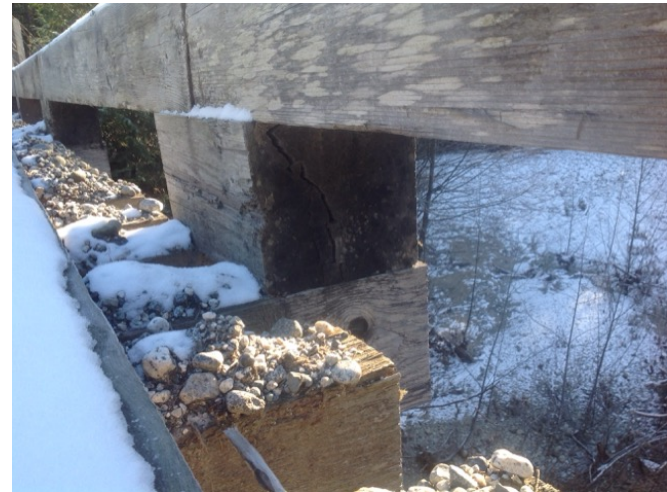
rotten and splitting risers

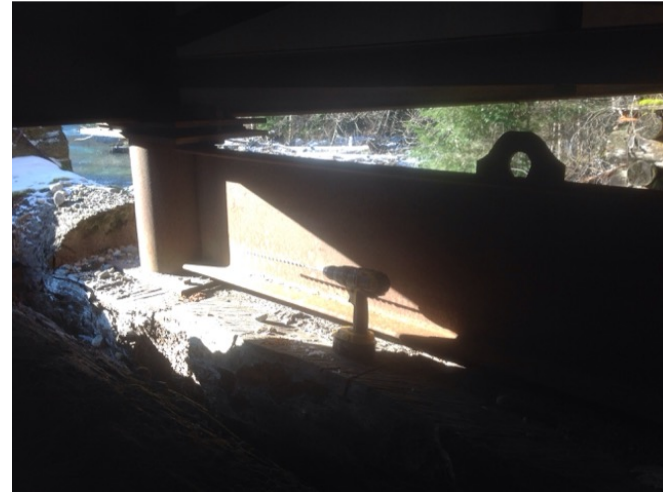
| Bearings | Poor | cracked on left span and rotting on right span |

right span pier bearing

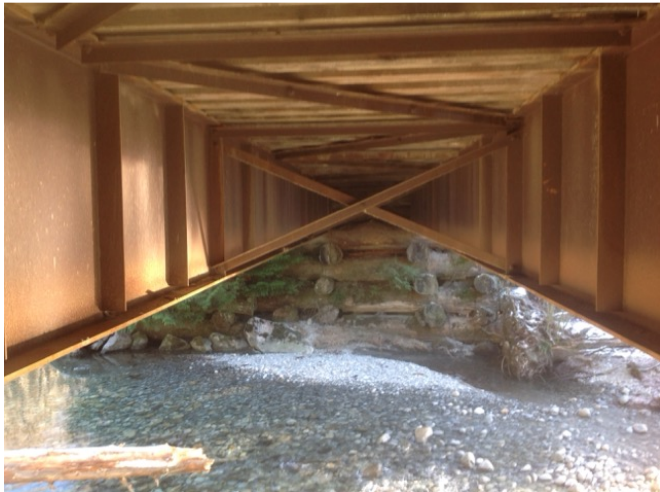
left span superstructure

| Girders | Fair | left span approx 50mm higher than right span |

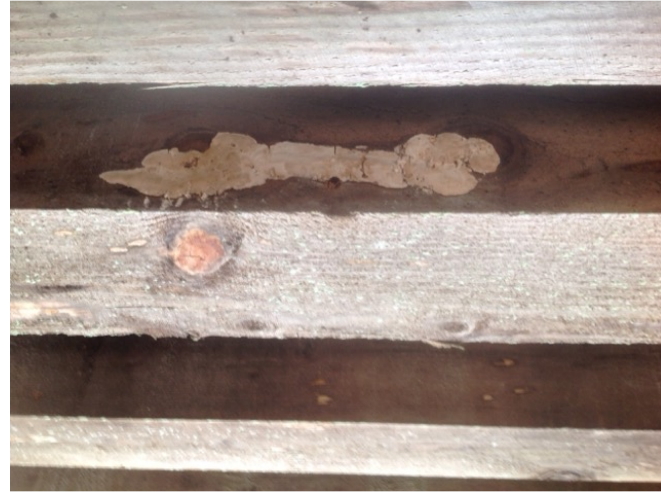
| Ties | Fair | 200mm x 300mm - some are showing signs of rot |

more ties that are rotting

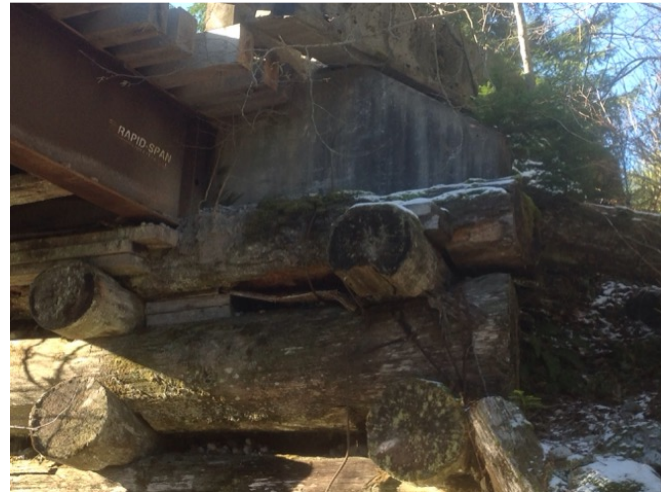
top crib log on right abutment Fd and in relatively poor shape
