CK-2262

STAVE RIVER 10.5km

2014 Inspection

Superstructure Log Stringers

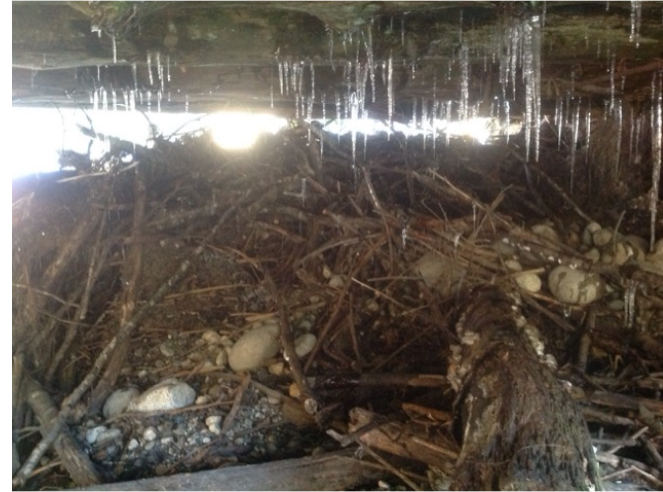
debris under structure

| 1 | debris accumulations | routine inspection |

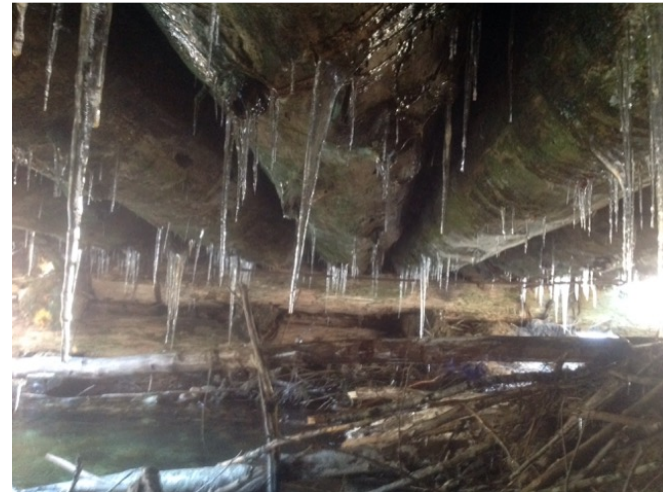
This structure has 2 layers of stringers and only the bottom layer can be properly assessed. The top layer of stringers that were added in 2012 was a temporary repair in order to facilitate works at the time. The structure has had further deterioration of the bottom layer of stringers, the crib logs and the tiebacks. This, combined with no way of properly assessing the top layer of stringers has resulted in a down rated structure. Limit loading to 30 tonnes, please post. Replace entire structure prior to industrial activity.

| 1 | Cw | Y | 740 | 100 | sap and pocket rot detected |
| 2 | Cw | Y | 820 | 100 | sap and pocket rot detected |
| 3 | Cw | Y | 700 | 60 | sap rot |
| 4 | Cw | Y | 760 | 150 | sap and heart rot detected |
| 5 | Cw | Y | 750 | 150 | sap and heart rot detected |
| 6 | Cw | Y | 700 | 50 | sap rot |
| 7 | Cw | Y | 750 | 50 | sap rot |

stringers

| Repair Item | Priority | Repair Description |
|---|---|---|
| 3 | High | remove gravel and properly assess top layer of stringers |
