CK-2263

STAVE RIVER 11.4km

2014 Inspection

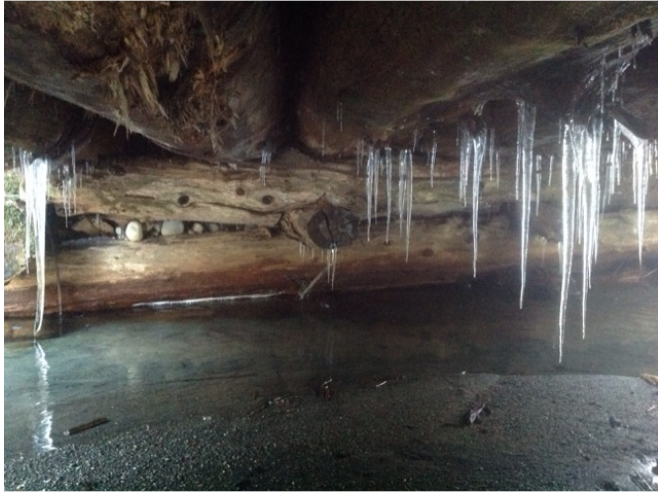
Left Bank Abutment when facing downstream

Log/Timber Cribs Fair fair to poor, left top crib log has horizontal crack

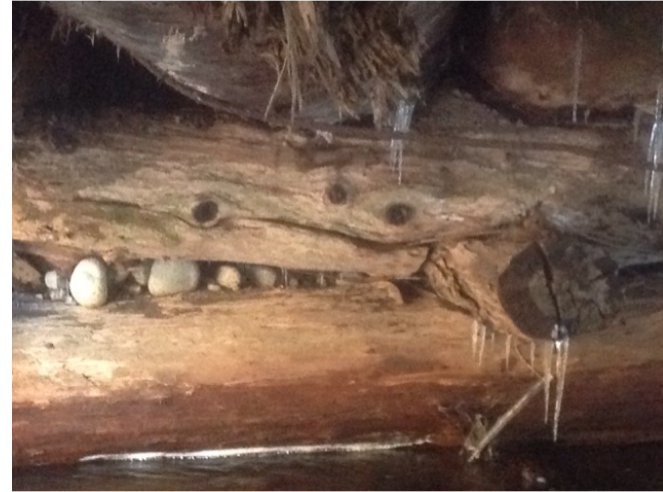
Bearings Fair fair to poor due to left abutment crib

top crib log on left abutment has horizontal crack
