CK-2264

STAVE RIVER 13km

2014 Inspection

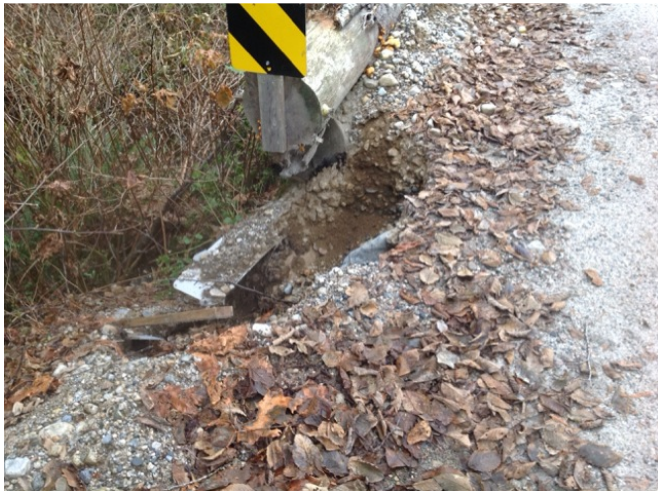
right bank upstream erosion
