CK-2267

STAVE RIVER 19km

2014 Inspection

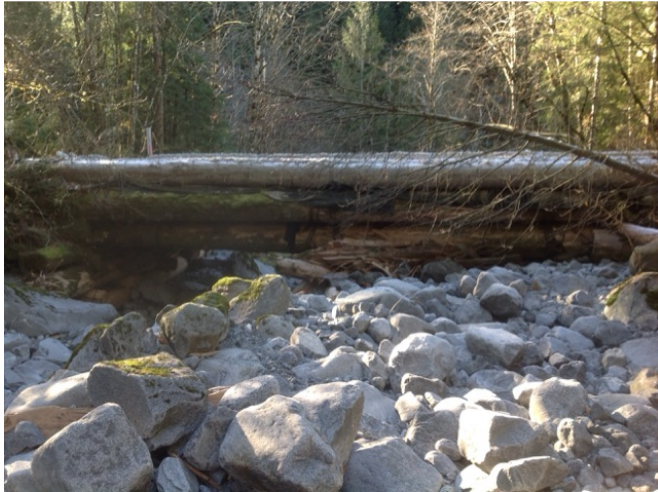
Inlet

| 1 | inlet aggradation | Anually |

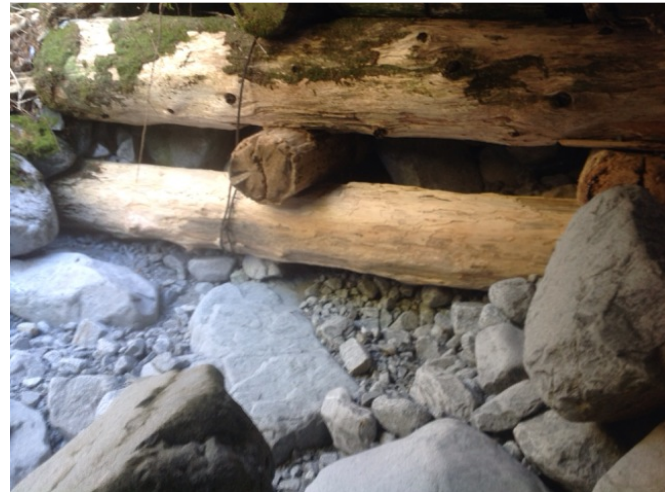
scouring left upstream

left abutment upstream scour

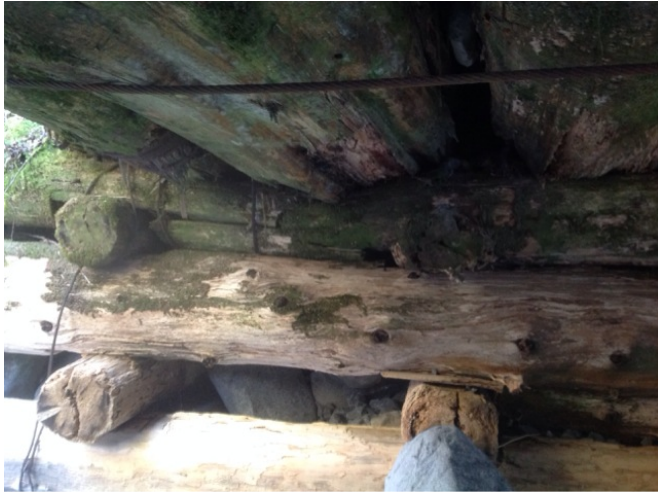
crushing top crib log on left upstream

crushing top crib log on left side

left abutment upstream top crib log crushing

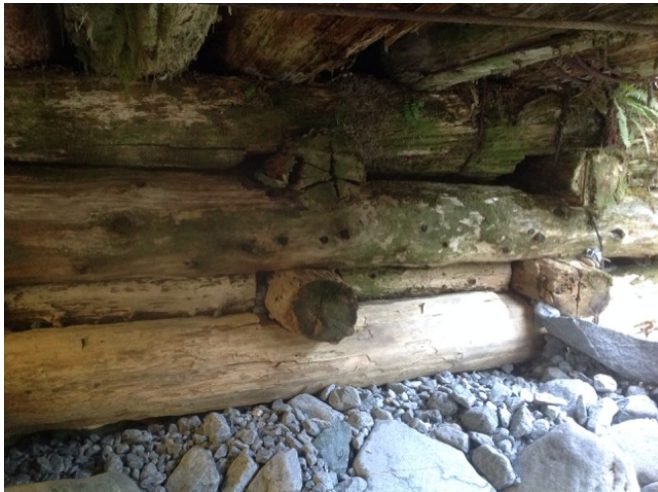
rotting and splitting

tie backs - typical

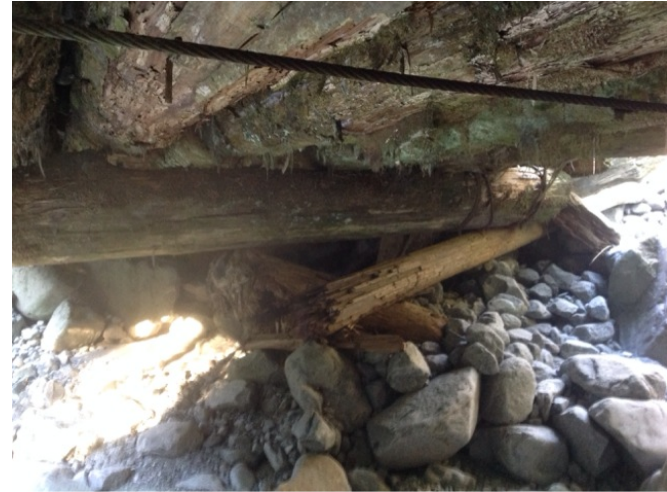
Needle Beam Poor loose and non functional

Needle Lashing/  
Shimming Poor loose and non functional

needle beam loose and material wedged under upstream

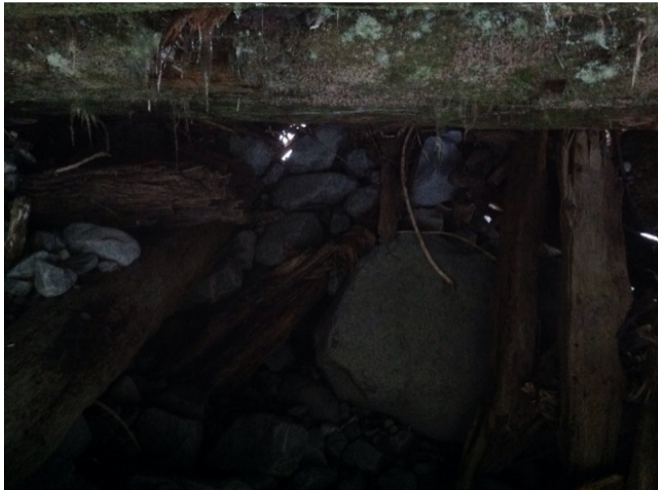
blocked portion of inlet viewed from under structure

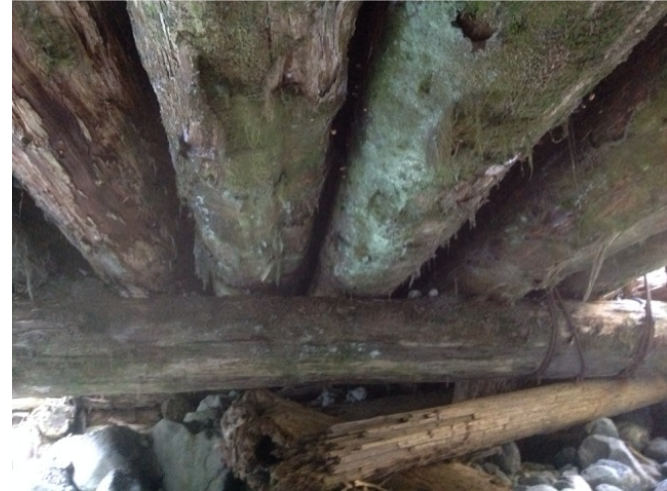
This structure has 2 layers of stringers and only the bottom layer can be properly assessed. The top layer of stringers that were added in 2012 was a temporary repair in order to facilitate works at the time. This structure has had further deterioration of the bottom layer of stringers, the crib logs, and the tiebacks. This, combined with no way of properly assessing the top layer of stringers has resulted in a down rated structure. Limit loading to 30 tonnes, please post. Replace entire structure prior to industrial activity.

bottom layer of stringers

| Repair Item | Priority | Repair Description |
|---|---|---|
| 2 | High | replace prior to industrial activity |
