CK-2268

STAVE RIVER 20km

2014 Inspection

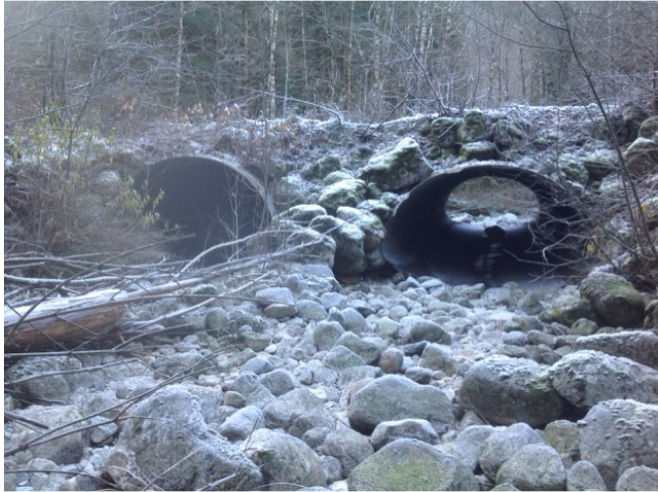
Inlet Fair aggrading

1 aggradation

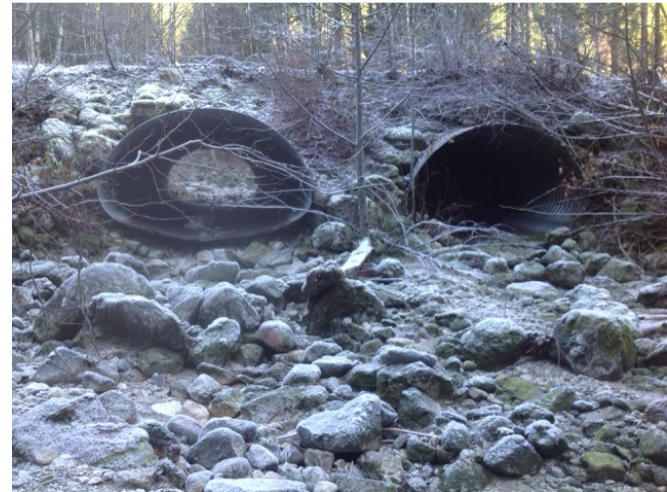
Outlet Fair 0.8m plunge pool on right bank culvert
