CK-2272

STAVE RIVER 26.7km

2014 Inspection

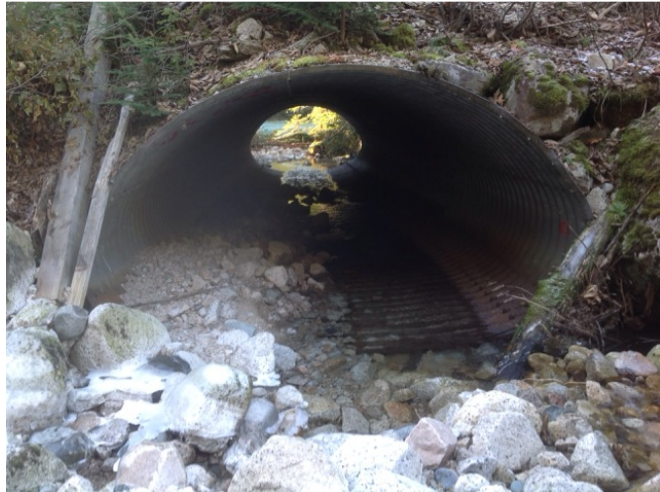
Inlet Fair aggrading

Aggradation ☒Scour ☐

1 aggradation

Routine Inspection

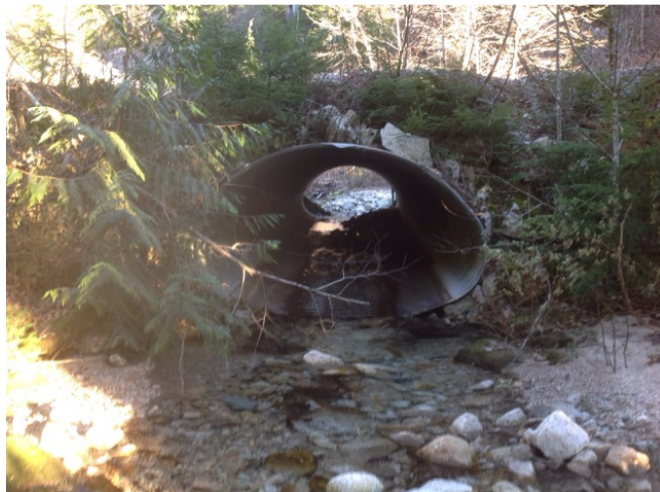
Outlet Fair
