CK-2278

SUMALLO RIVER 1.4km

2014 Inspection

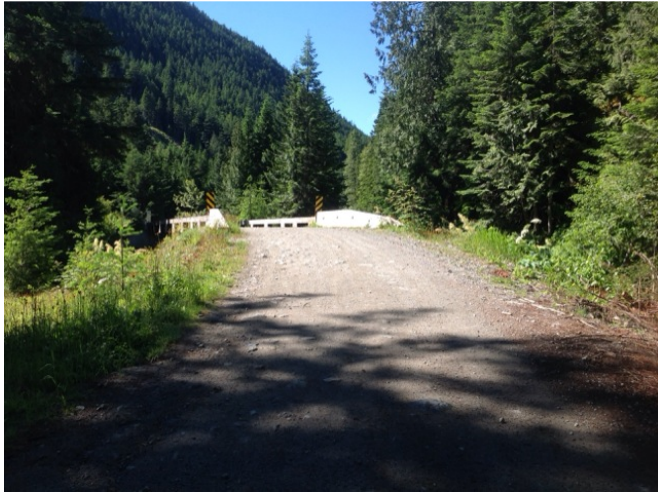
Approach from Left Bank when facing downstream

vertical and horizontal on left approach

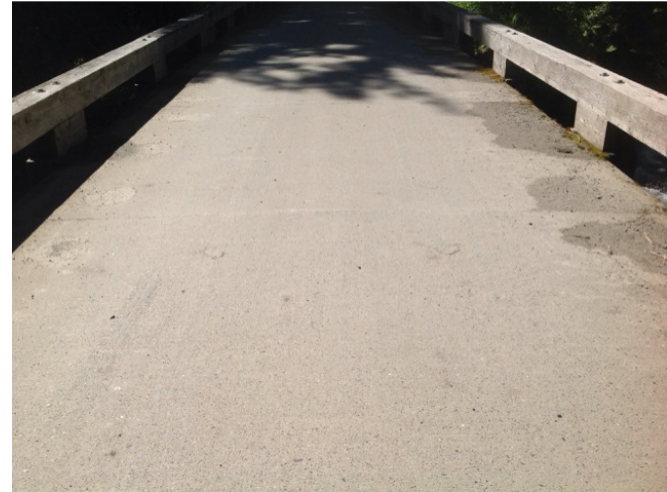
Overall Deck Condition Fair

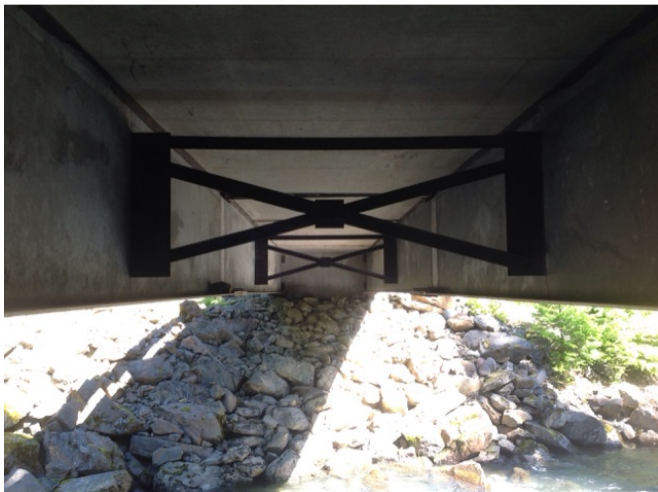
Girders    Good       composite girders

composite girders

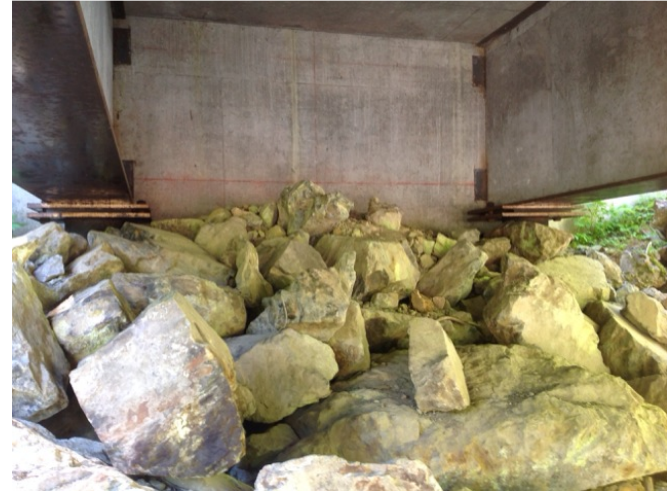
Caps or Sills Good steel plates and rubber pads

right bearing plates

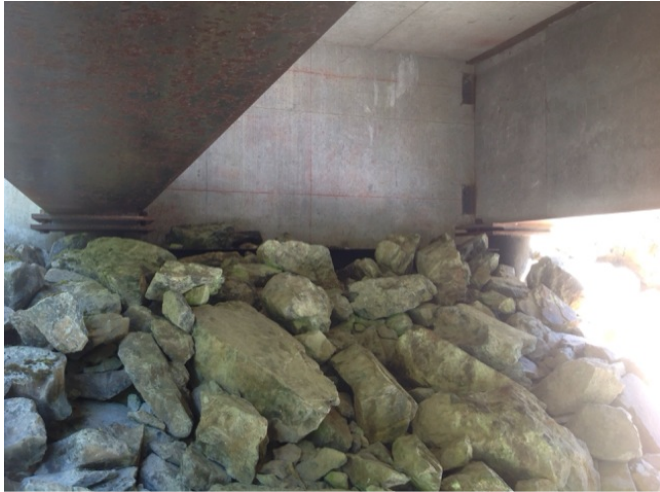
right bearing plates
