CK-2287

SILVERHOPE 0.6km

2014 Inspection

Date of Inspection 2014-10-23 12:28:04 PM

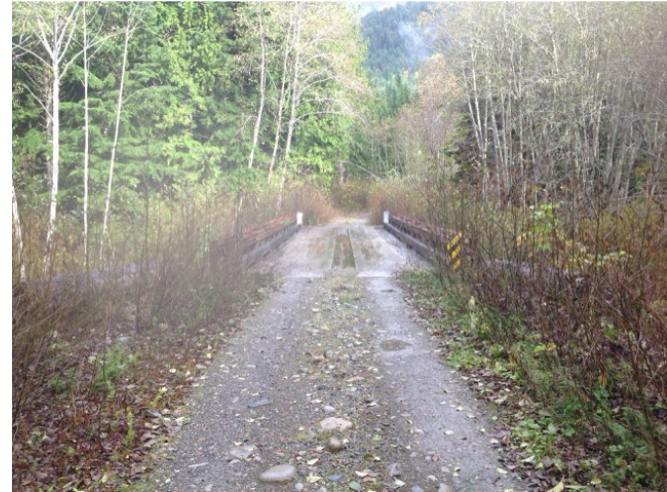
Approach from Left Bank when facing downstream

Delineator Missing  
Left ☐ 0 ☒ 1 ☐ 2Delineator Missing  
Right ☒ 0 ☐ 1 ☐ 2

| Repair Item | Priority | Repair Description |
|---|---|---|
| 2 | Medium | replace missing delineator |

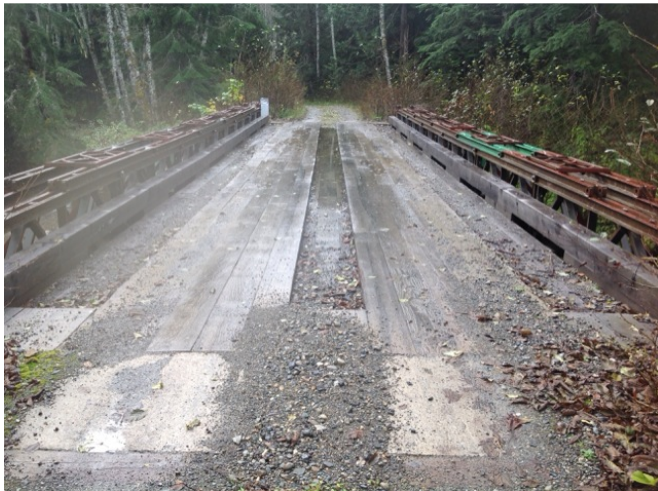
Running Planks Fair

Deck to Girder Bolts Poor none

Overall Deck Condition Fair

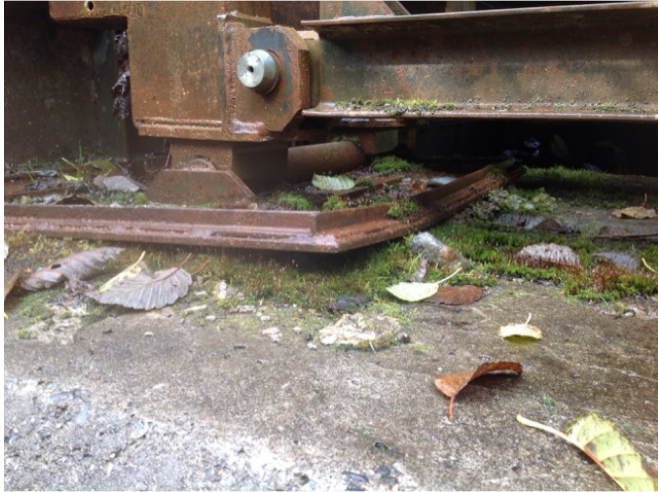
left upstream bearing

Bearings Fair

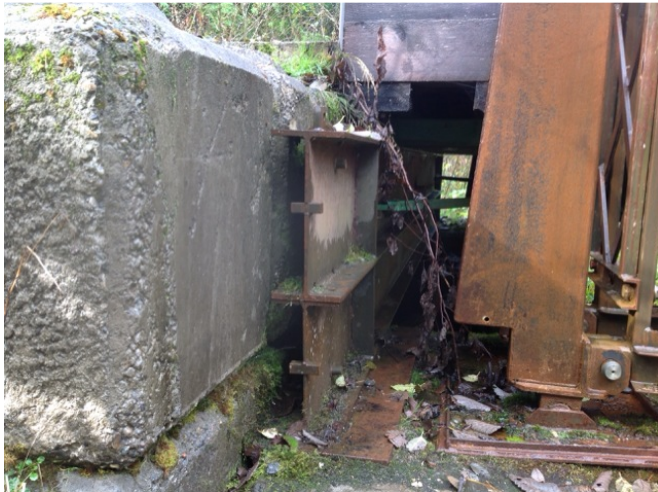
typical ballast wall

Ballast Wall Fair lockblocks

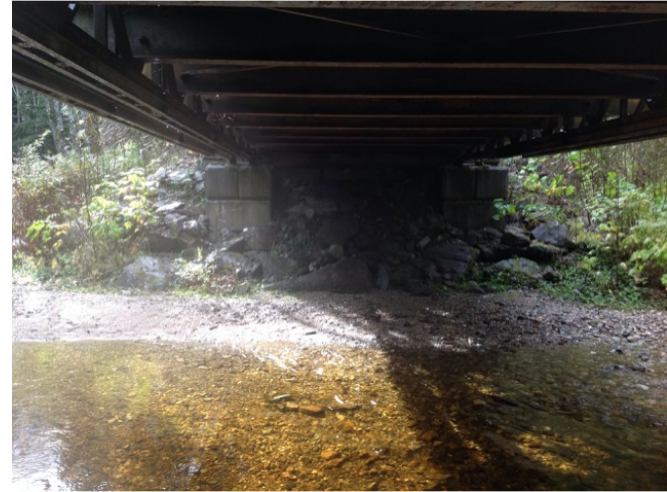
Left Bank Abutment when facing downstream

Concrete Fair 4 lock block columns

Wing Wall Fair lock blocks
