CK-2300

UZTLIUS CREEK 13.4km

2014 Inspection

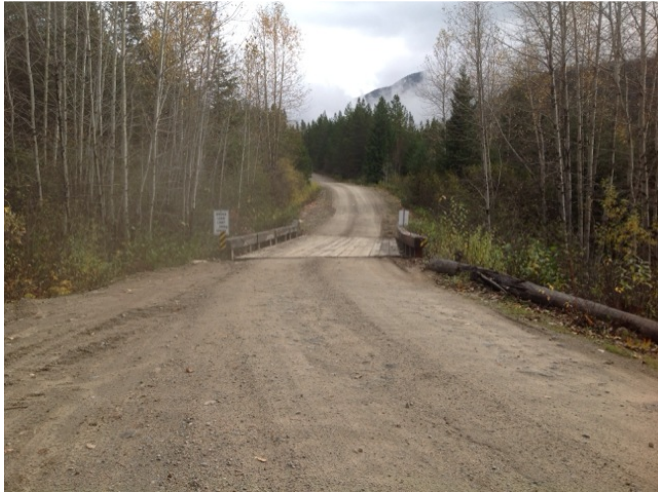
Approach from Right Bank when facing downstream

Fender Condition Poor missing upstream right, both left approach and too low downstream right

Place fenders at approaches, replace wrong handed delineators and post bridge ahead signs.  
Continue to monitor the structure annually. Present load rating of L75 or 68 tonnes to continue.

| Repair Item | Priority | Repair Description |
|---|---|---|
| 3 | Medium | replace fenders |

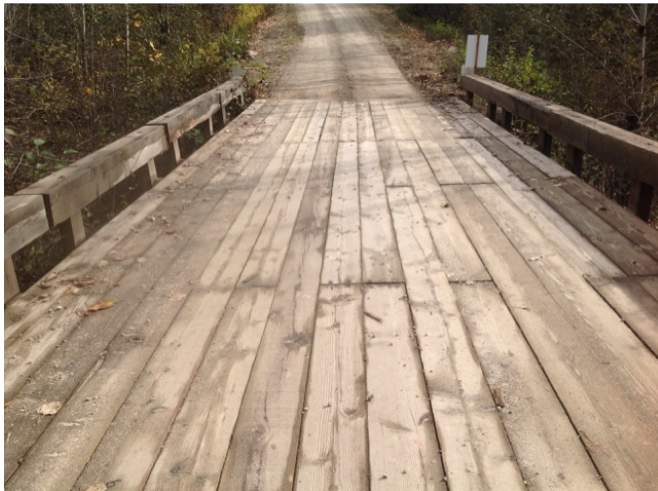
Deck

Running Planks Fair not staggered properly

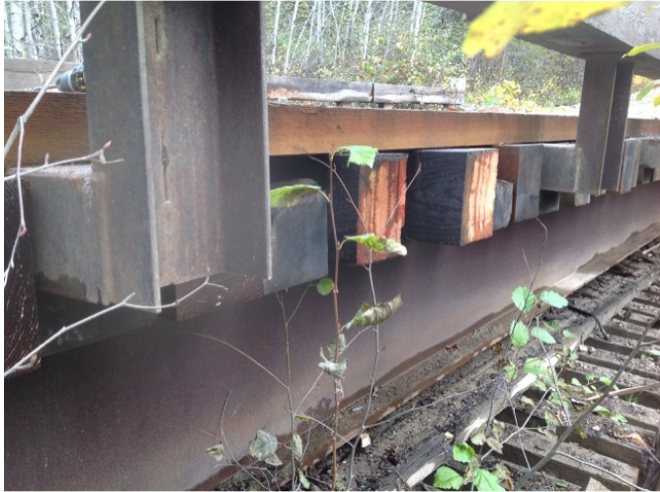
Ties Fair some recently added

new ties added

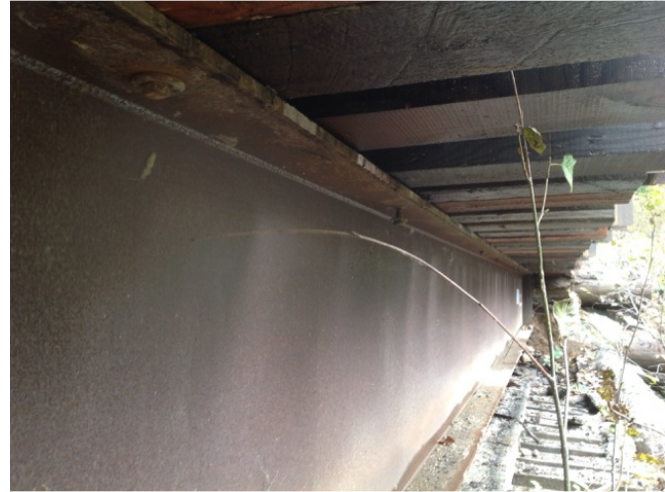
Deck to Girder Bolts Fair

deck to girder bolts

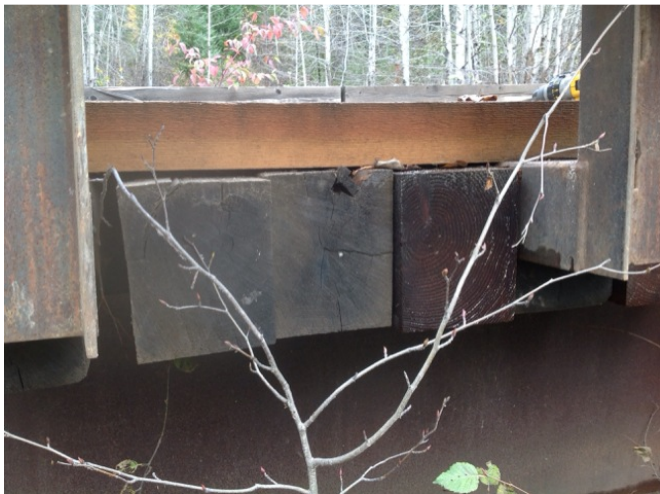
new ties added

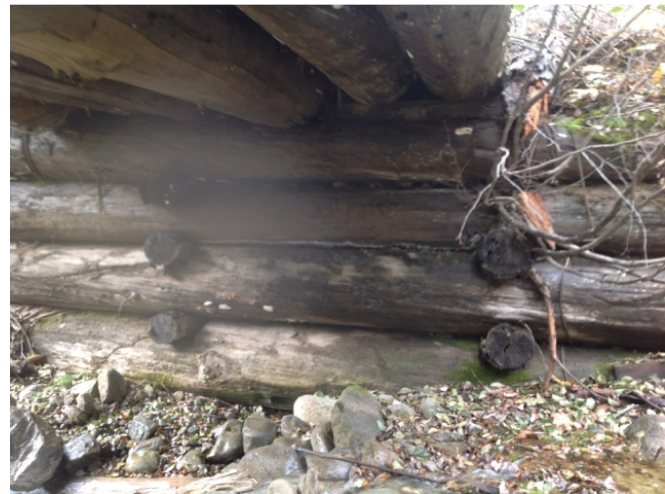
Log/Timber Cribs Poor fill retention, undermined on left downstream

Riprap Poor none in front of old crib

old right crib

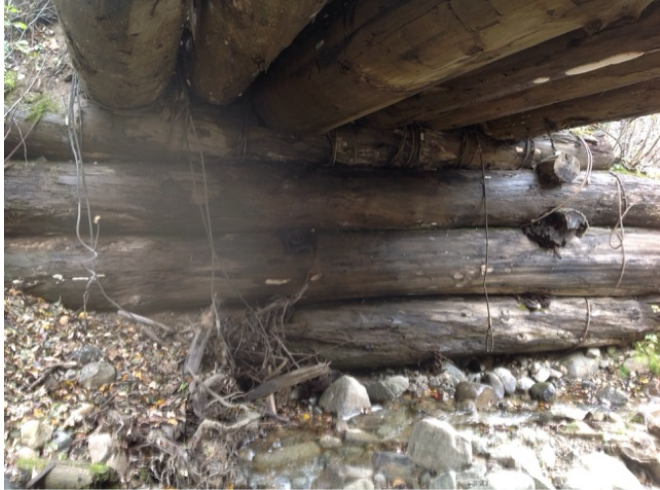
old left crib
