CK-2306

UZTLIUS-E ANDERSON 27.2km

2014 Inspection

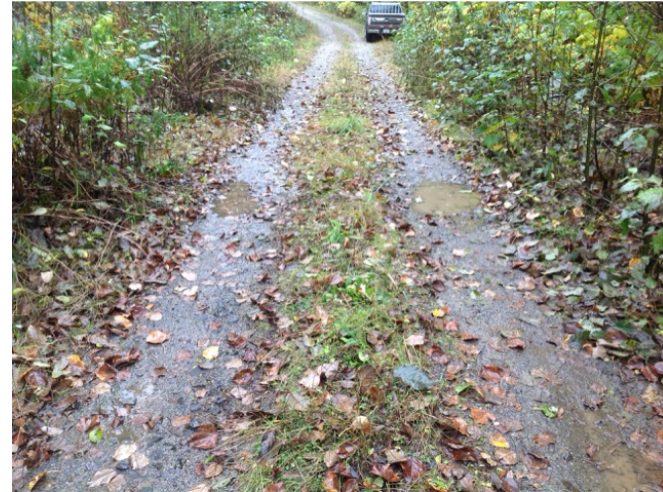
Curb Rail/Blocks/Posts Poor too low

Overall Deck Condition Poor due to rail

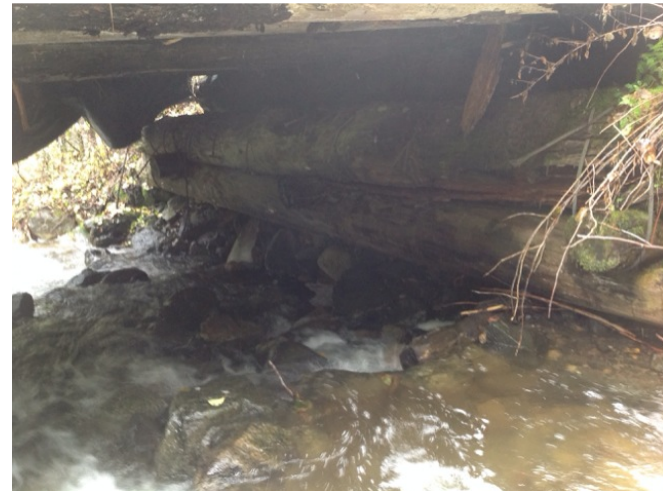
Right Bank Abutment when facing downstream

Log/Timber Cribs Poor 2x both sides - right side scoured downstream - fill retention

Caps or Sills Poor single log sill each end - right bank scoured

Bearings Poor due to undermined (scoured) sill on right bank

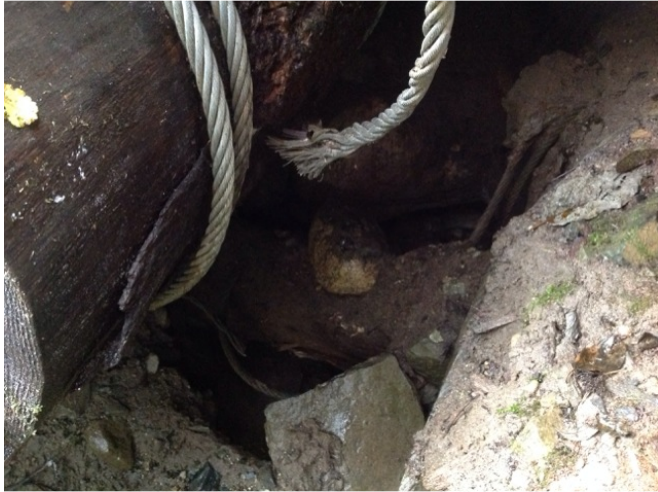
right bank downstream hole under sill
