CK-2307

UZTLIUS-E ANDERSON 12.8km

2014 Inspection

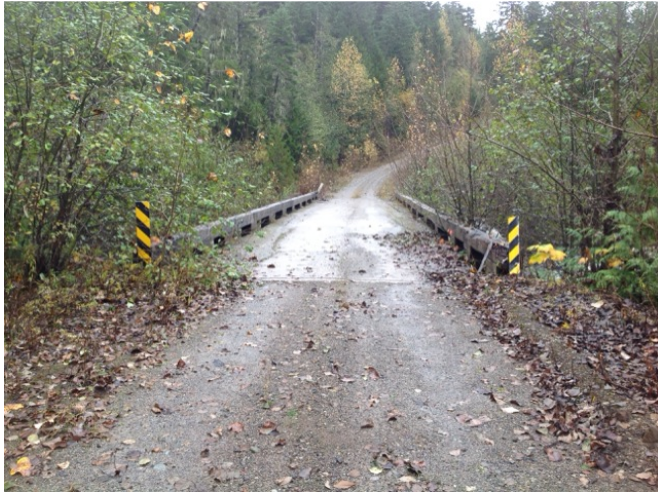
Approach from Left Bank when facing downstream

Alignment Fair

Fender Condition Poor

| Repair Item | Priority | Repair Description |
|---|---|---|
| 2 | Medium | brush approaches |
| 3 | Medium | replace missing bridge ahead signs |

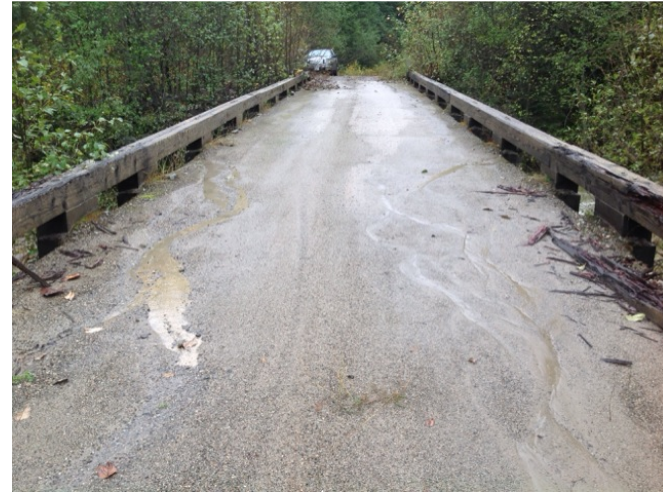
Running Surface Fair sediment running onto bridge deck

Concrete Deck Fair minor track damage, spalling under panel 1 - rebar exposed and rusting but not heavy

Curb Rail/Blocks/Posts Poor rotten and damaged

Hardware Poor loose rail

Overall Deck Condition Poor due to rail

| Repair Item | Priority | Repair Description |
|---|---|---|
| 1 | High | replace guardrail with activity |

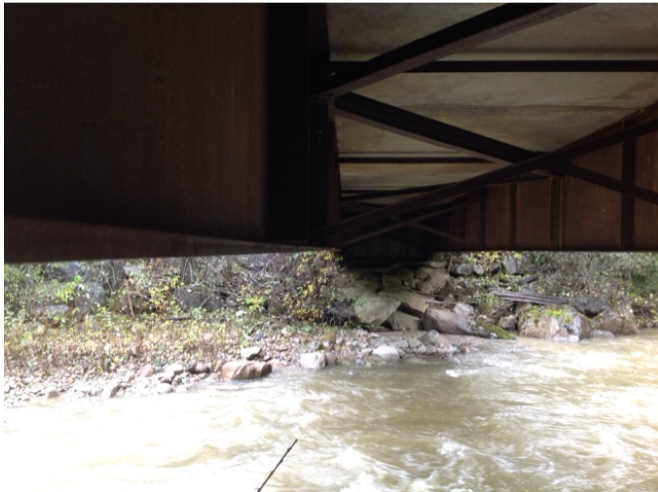
both girders have slight undulations in the bottom flange where the girders were welded
