CK-2308

UZTLIUS-E ANDERSON 29.3km

2014 Inspection

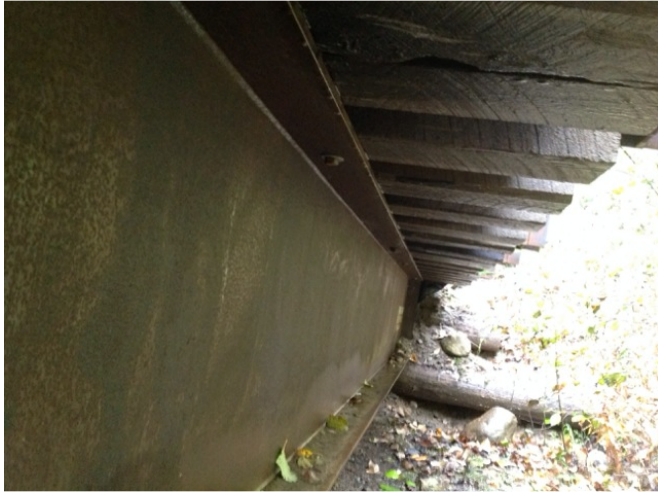
deck bolts

Deck to Girder Bolts Good

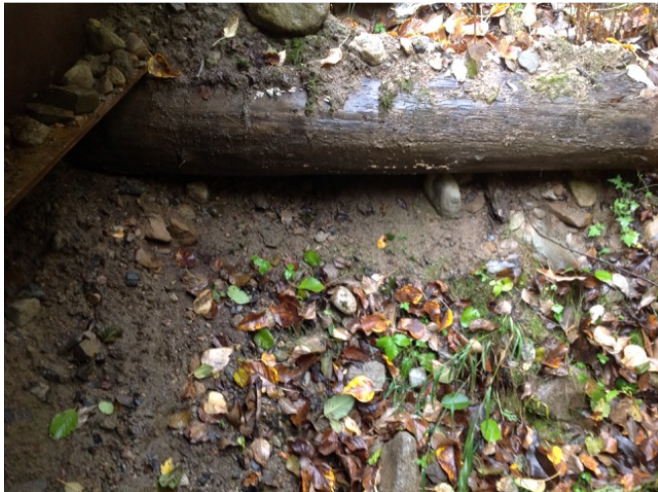
right upstream bearing

scoured upstream right approach

failing under right upstream sill

Bearings Poor

undermined log sill right upstream
