CK-2309

UZTLIUS-E ANDERSON 17.1km

2014 Inspection

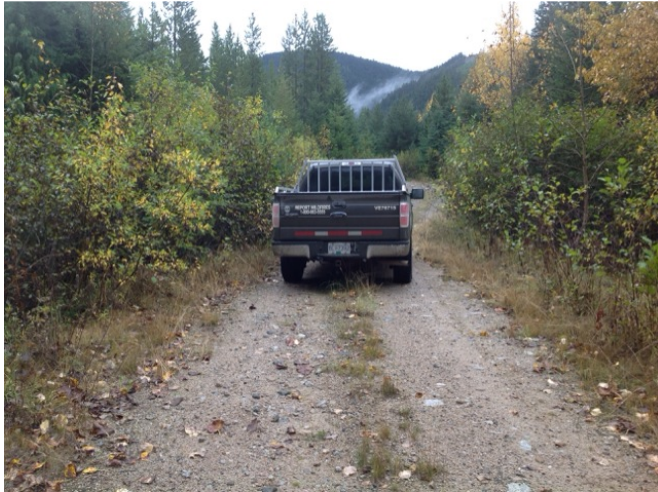
Approach from Right Bank when facing downstream

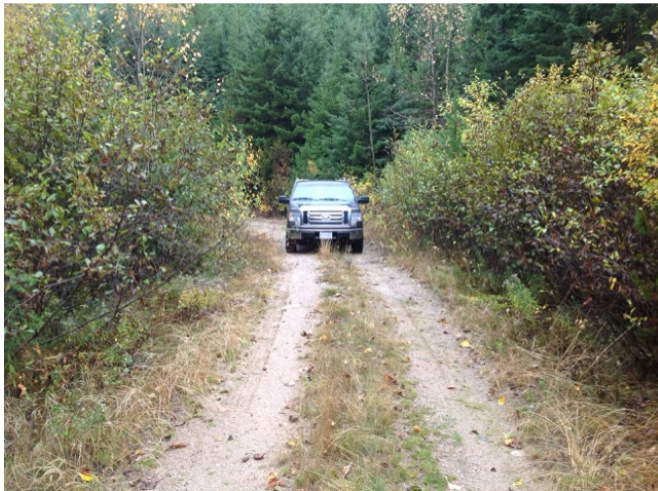
Approach from Left Bank when facing downstream

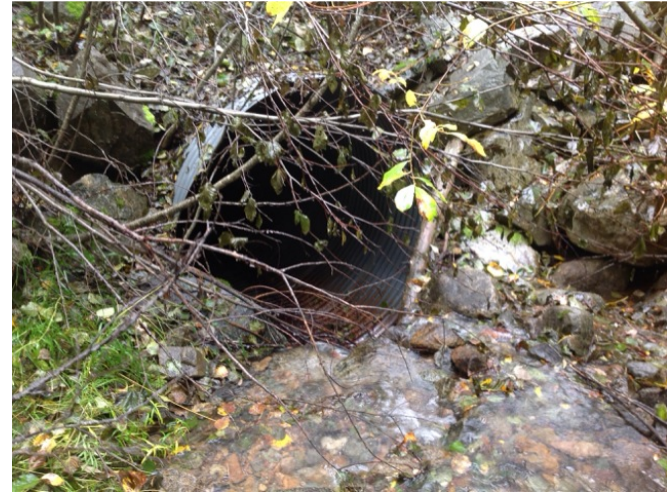
Inlet Fair aggrading

1 aggradation

routine inspection

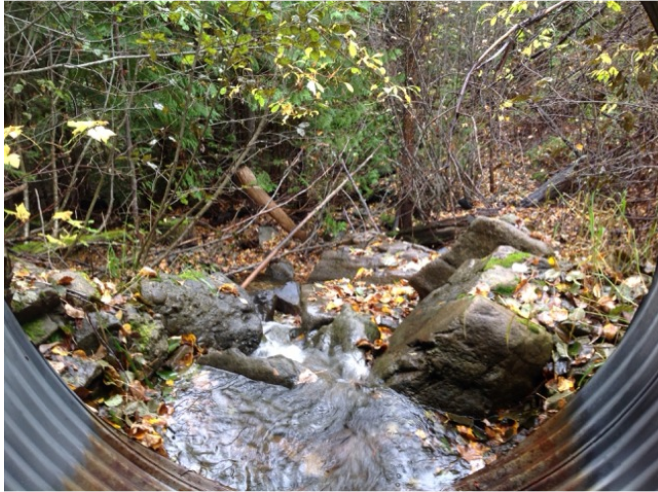
Outlet Fair
