CK-2310

UZTLIUS-E ANDERSON 18.5km

2014 Inspection

| Structure Class | Major Culvert |

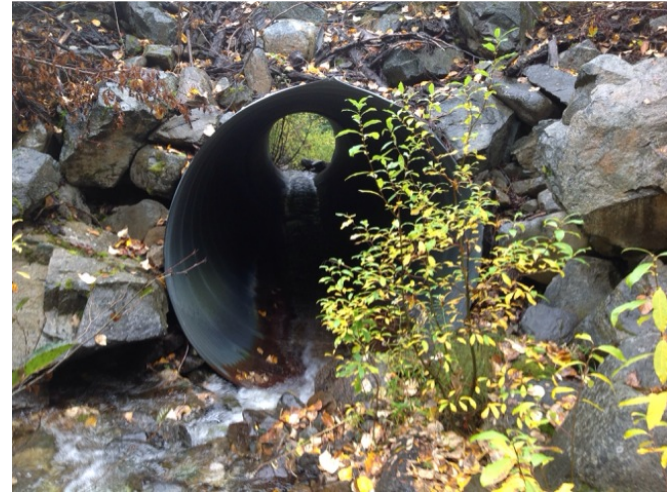
Inlet Good

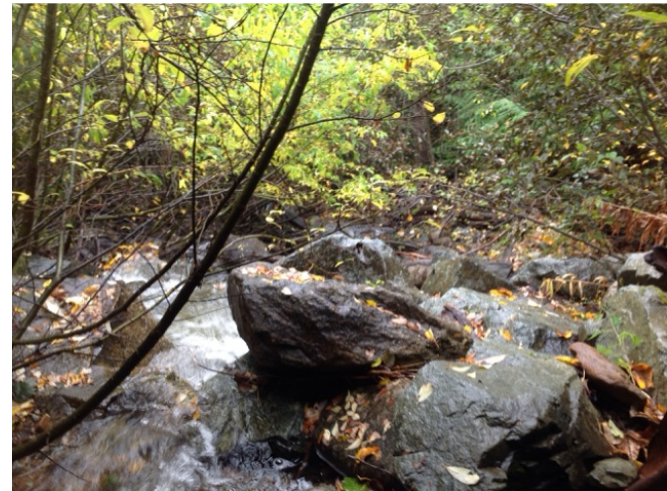
Outlet Good
