CK-2332

STAVE RIVER 1.4km

2014 Inspection

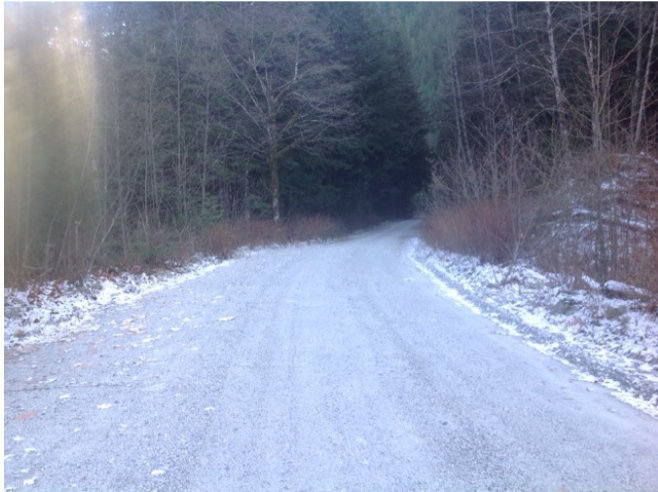
Approach from Left Bank when facing downstream

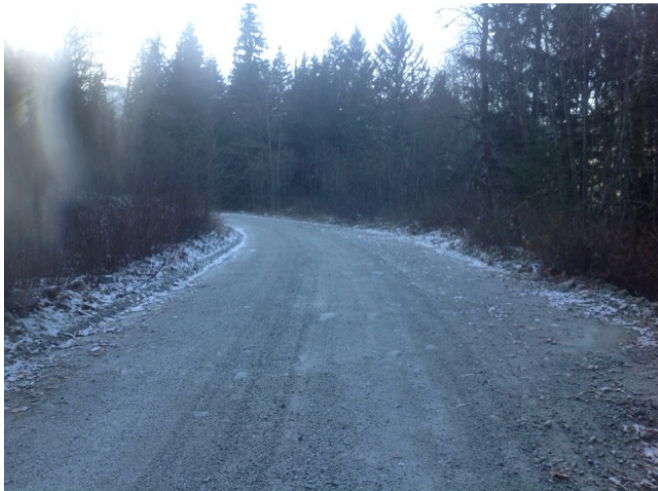
Approach from Right Bank when facing downstream

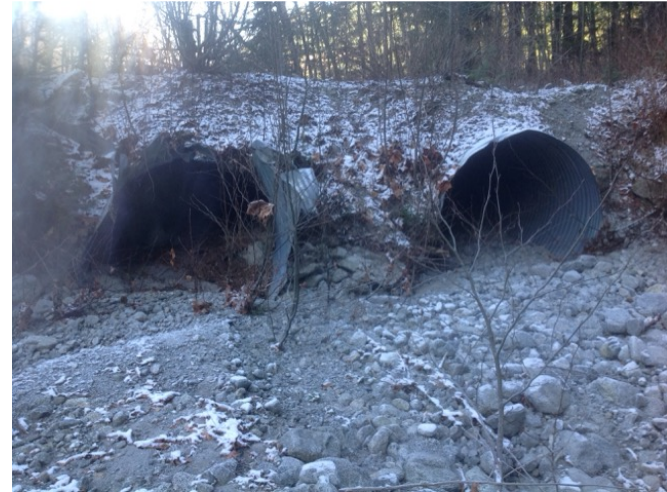
Inlet Fair damage to 1 of the culverts but still functional

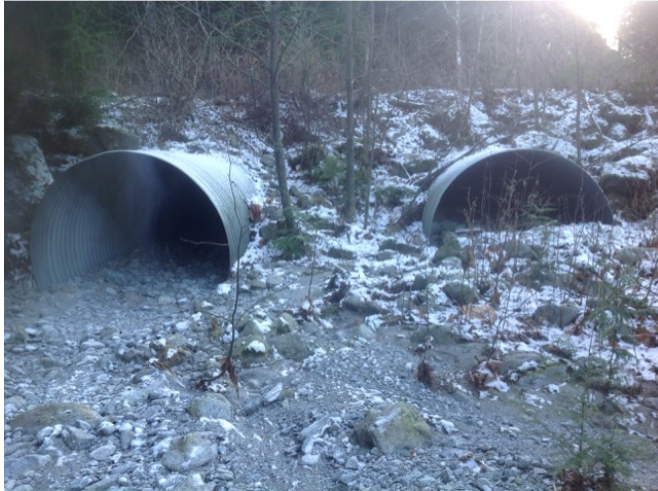
Outlet Fair 1 half plugged

Clear outlet. Present load rating of L75 or 68 tonnes to continue.
