CK-2333

STAVE RIVER 3km

2014 Inspection

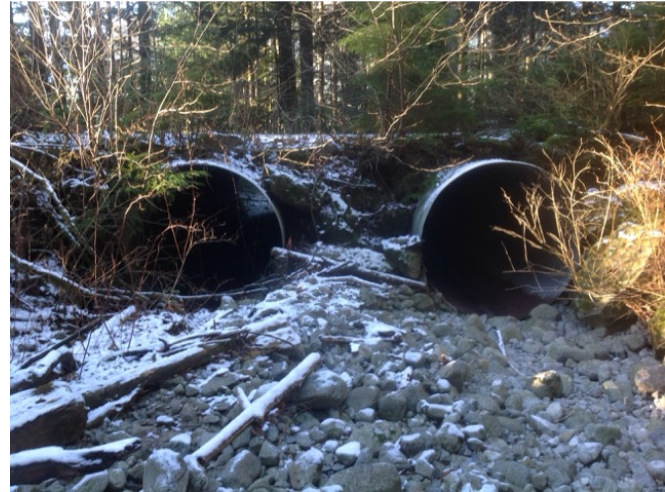
Inlet Fair

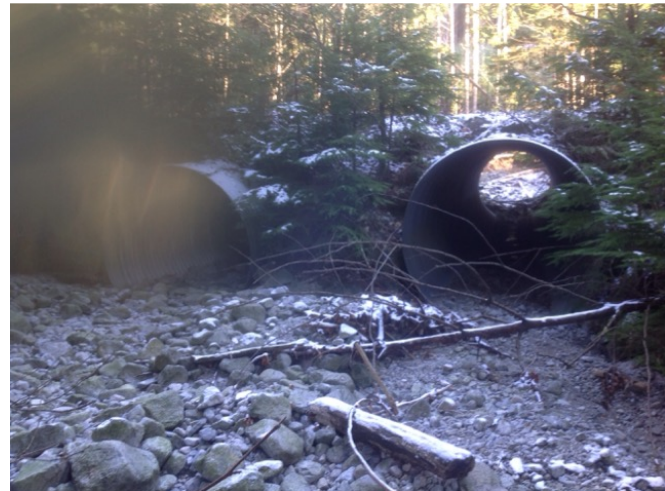
Outlet Fair
