CK-2334

STAVE RIVER 4.4km

2014 Inspection

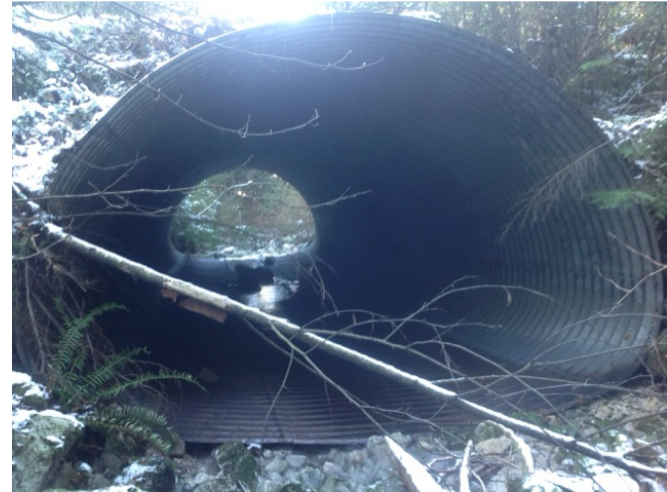
Inlet Fair

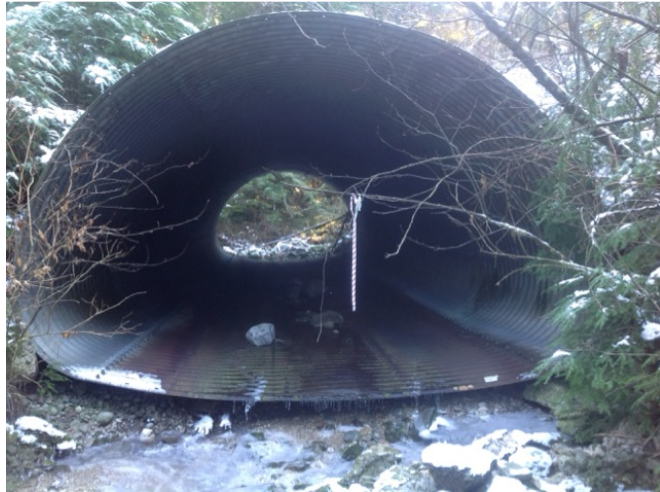
Outlet Fair
