CK-2337

STAVE RIVER 10.8km

2014 Inspection

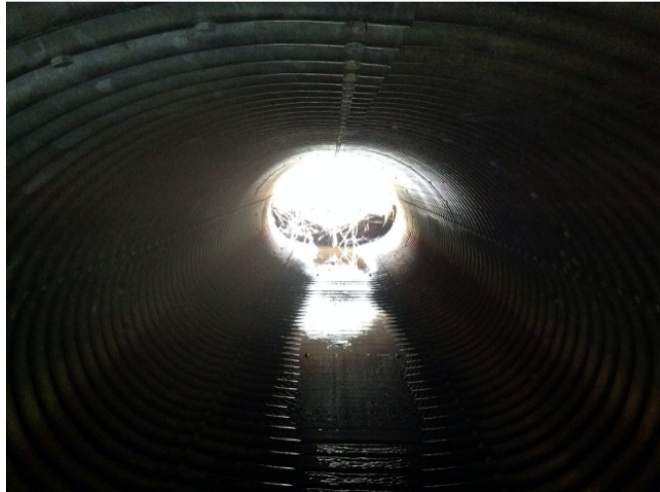
Outlet Poor standing water - debris buildup and poor/slow drainage

Overall Poor due to standing water

debris at outlet

Monitor debris buildup and poor/slow drainage. Present load rating of L75 or 68 tonnes to continue.

| | Monitor Description | Monitoring Frequency |
|---|---|---|
| 1 | <b>debris buildup and poor/slow drainage</b> | Routine Inspection |
