CK-2342

STAVE RIVER 20.1km

2014 Inspection

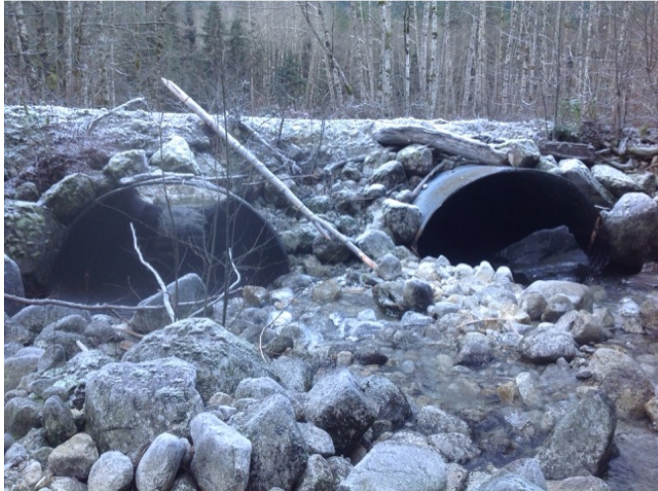
Inlet Fair aggrading

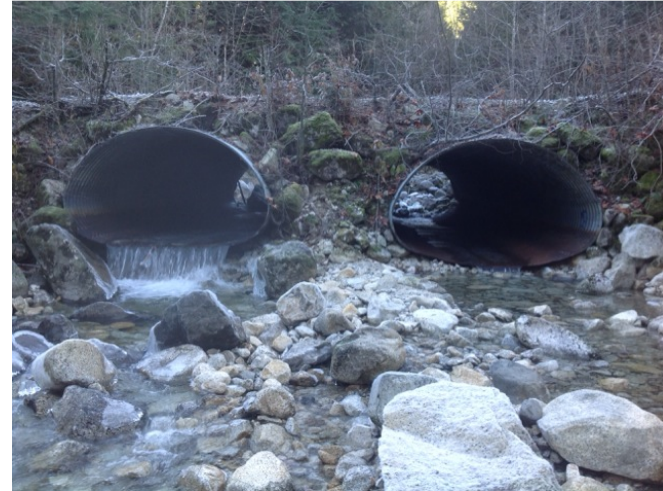
Outlet Fair 0.8m plunge pool on right bank culvert

Rip Rap Fair good at inlet, right bank outlet scoured

| 2 | right bank culvert outlet | Routine Inspection |

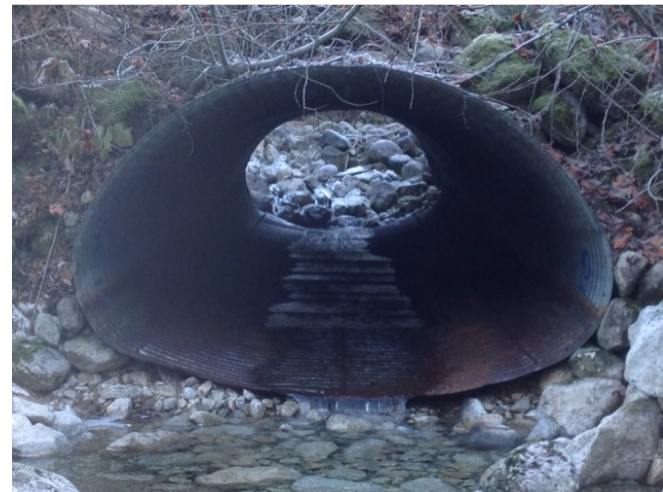
Aggradation ☒Scour ☐

approx 2.0 meters of aggradation noted at inlet

| 1 | aggradation | Routine Inspection |
