CK-2346

PITT-BOISE 0.9km

2014 Inspection

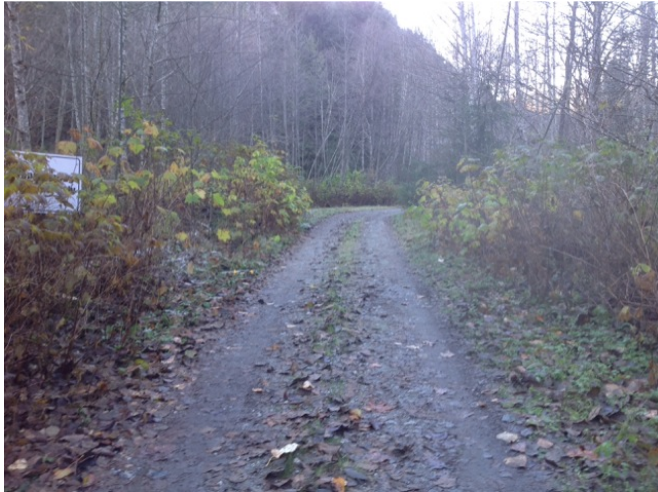
Approach from Right Bank when facing downstream

Bridge Ahead Signs  
Missing ☐ 0 ☐ 1 ☒ 2

Delineator Missing  
Left ☐ 0 ☐ 1 ☒ 2Delineator Missing  
Right ☐ 0 ☐ 1 ☒ 2

| Repair Item | Priority | Repair Description |
|---|---|---|
| 1 | L | brush approaches, post bridge ahead signs and replace missing delineators |

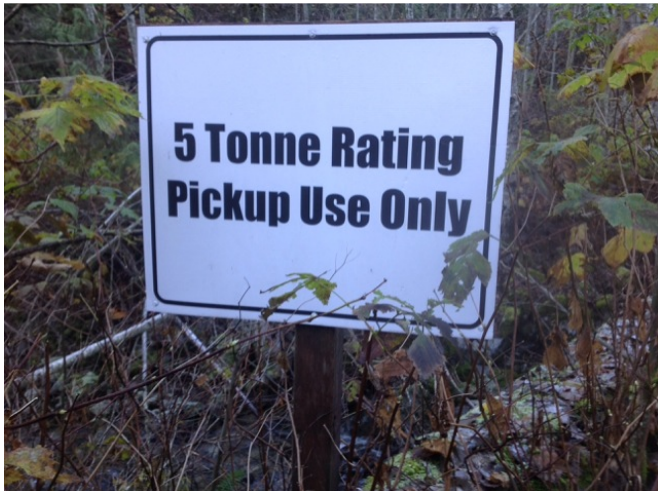
load rating sign

Posted Load Rating 5

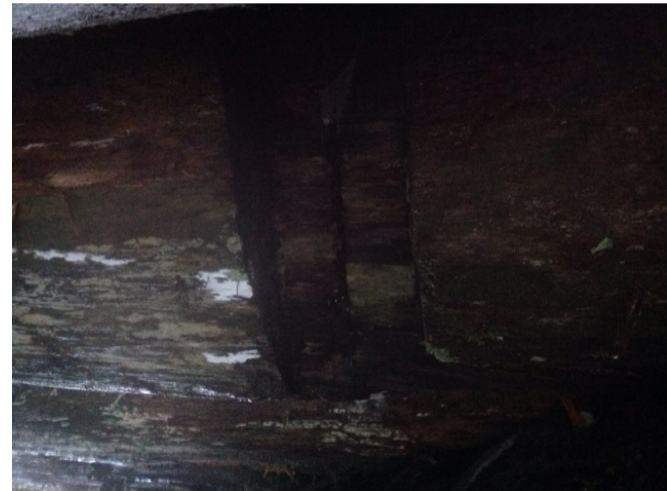
notched stringer

| Repair Item | Priority | Repair Description |
|---|---|---|
| 2 | H | replace structure |

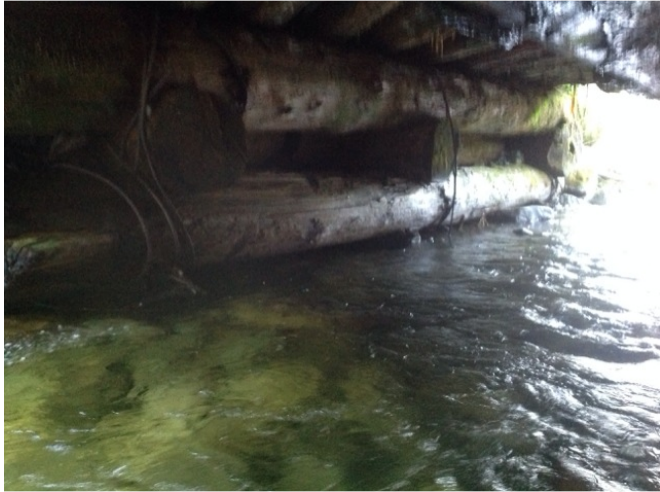
Left Bank Abutment when facing downstream

Log/Timber Cribs Fair - scoured

Hardware Poor loose lashing

Riprap Poor none
