CK-2354

HARRISON EAST 16.8km

2014 Inspection

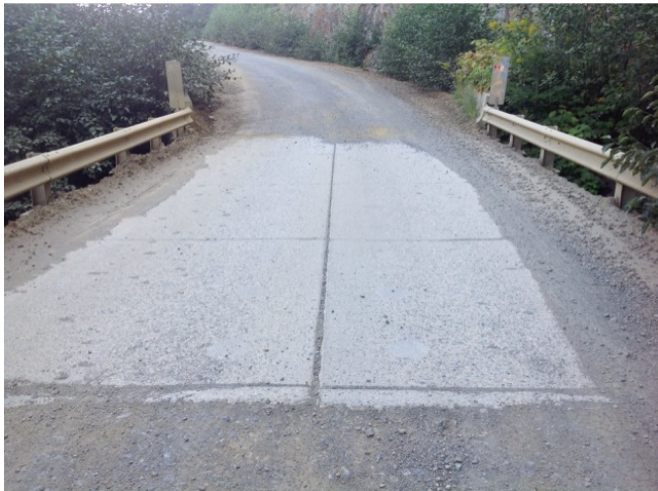
Overall Deck Condition Fair monitor deck joints

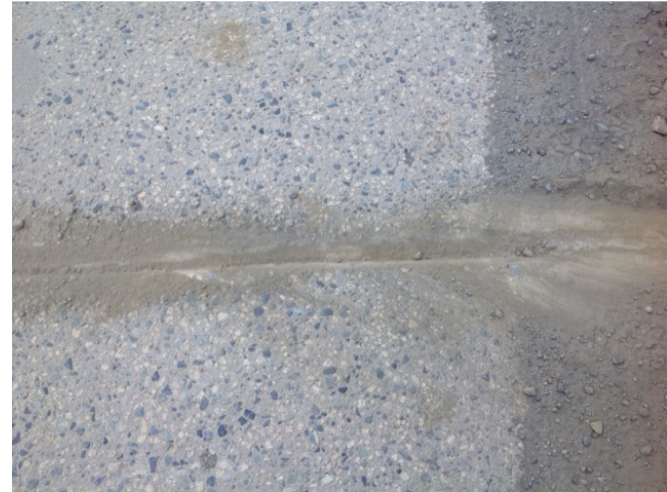
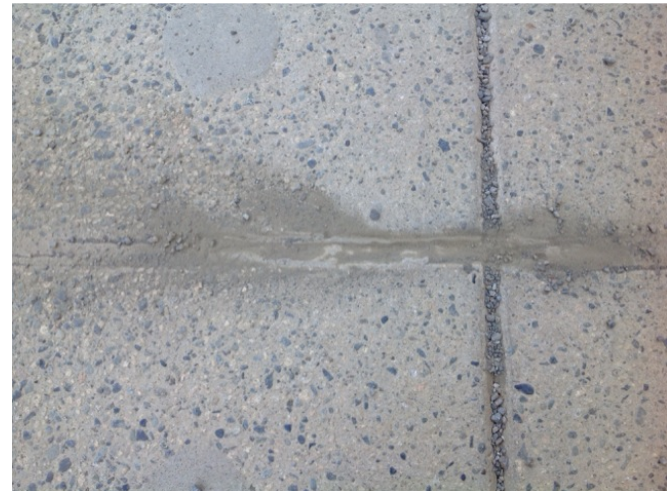
Deck Joints Fair grout chipping in localized locations and moisture appears to be going right through to bottom side of panels - panels on downstream are independent from upstream -

deck joints

Brush approaches and monitor deck joints. Present load rating of L100 or 91 tonnes to continue.

1 wearing deck joints in localized locations

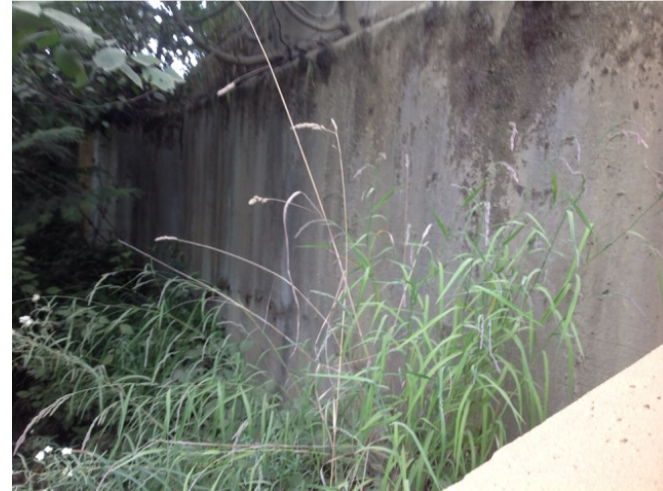
Wing Wall Fair 2 piece on right downstream

wing wall

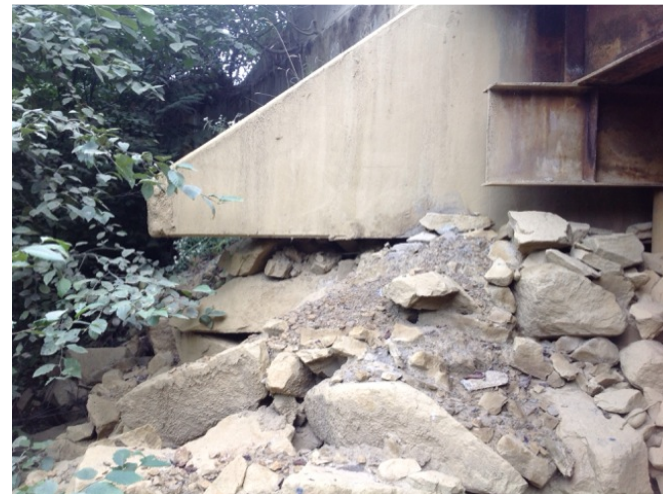
Ballast Wall Fair undermined right downstream however fill appears stable (riprap)

right downstream ballast wall

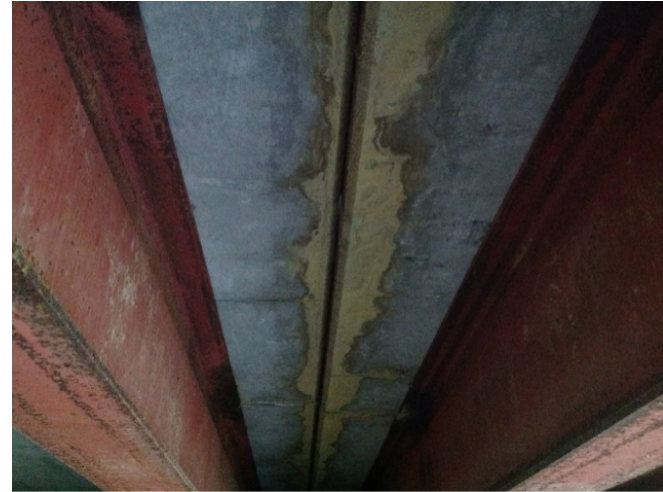
Concrete Deck Fair downstream panels different depth then upstream panels

differing depths of deck panels
