CK-2355

COGBURN CREEK 2km

2014 Inspection

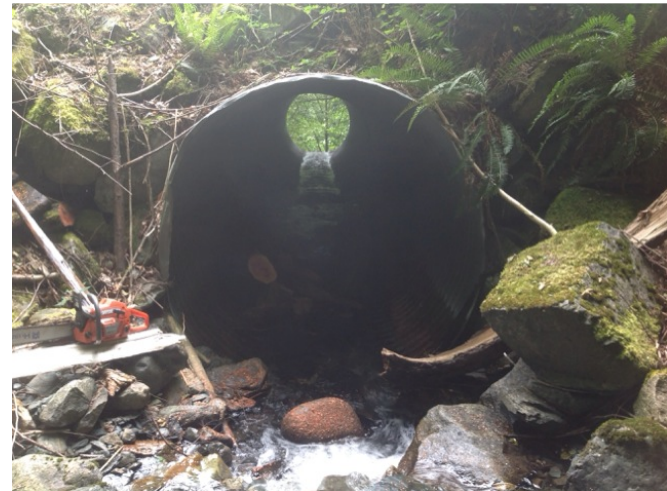
Inlet Fair debris buildup

1 debris buildup at inlet

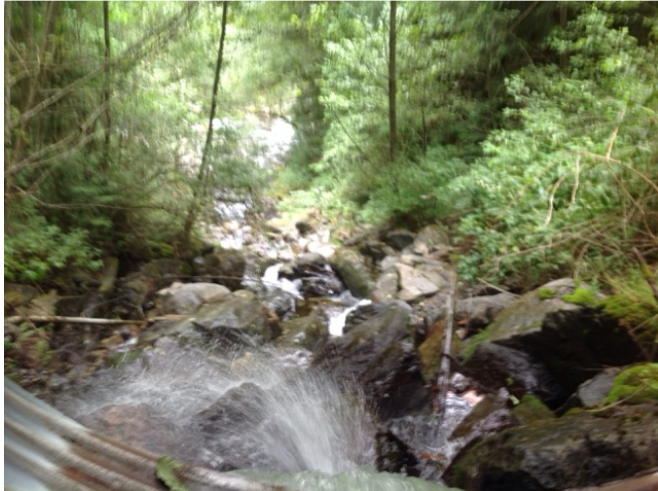
Downstream from Crossing

Outlet Fair steep drop out of culvert but we'll armoured
