CK-2356

KOOKIPI NINE 0.5km

2014 Inspection

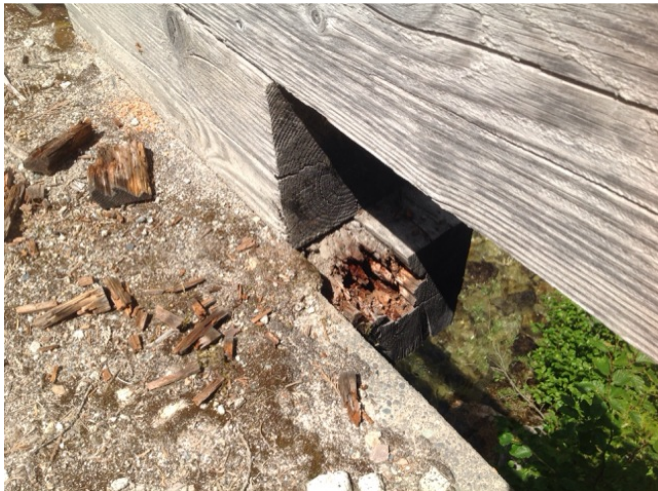
| Curb Rail/Blocks/Posts | Poor | rotten blocks and risers |

sideblock rot

| Repair Item | Priority | Repair Description |
|---|---|---|
| 1 | Medium | replace guardrail, risers and blocks |

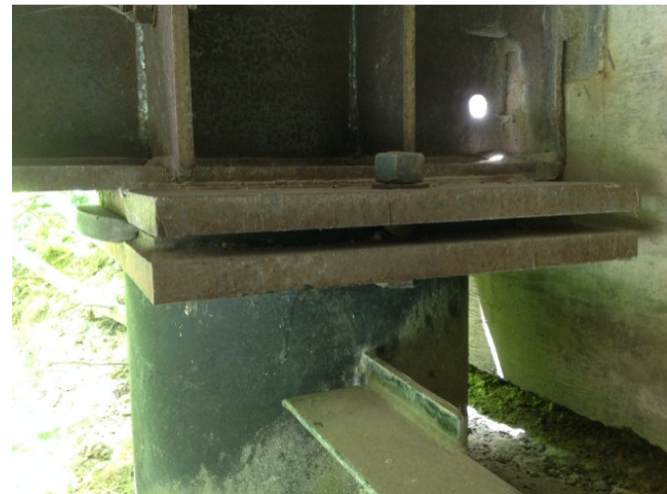
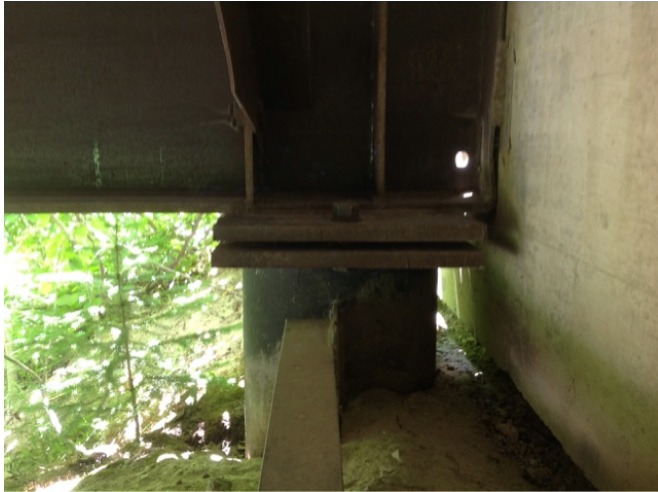
Caps or Sills Fair steel plates and rubber pads, left upstream pads buldging

| 1 | left upstream bearing pads | Routine Inspection |
