CK-2357

CANTELON TEN 0.1km

2014 Inspection

Structure Class Temporary Bridge

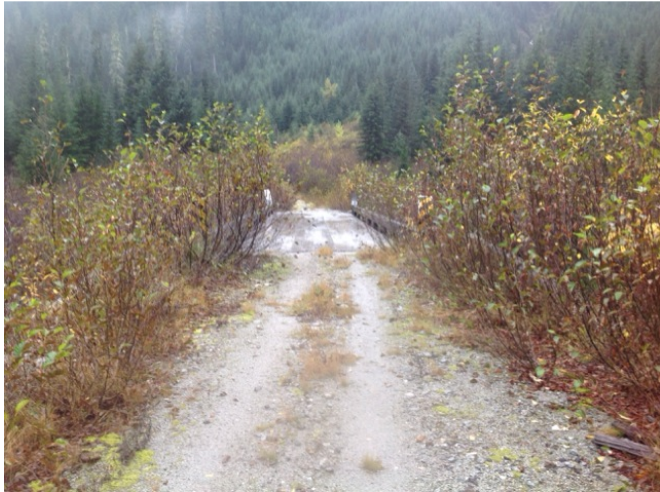
Approach from Right Bank when facing downstream

Road Surface Poor road grown over

| Repair Item | Priority | Repair Description |
|---|---|---|
| 3 | Medium | brush approaches with activity |

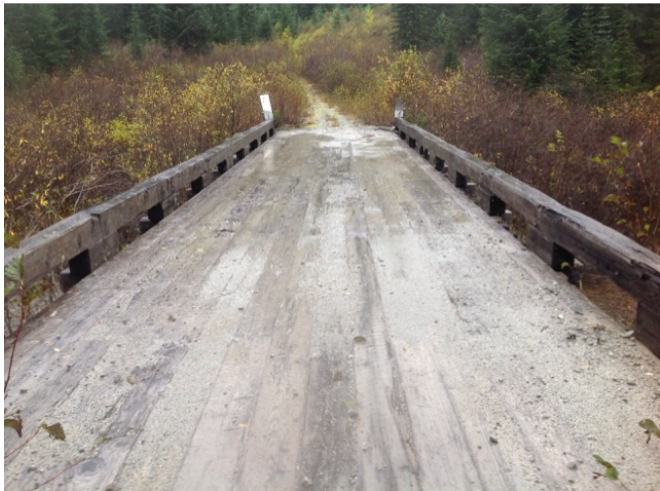
Running Planks Poor rotten

Ties Poor rotten

Curb Rail/Blocks/Posts Poor rotten

Overall Deck Condition Poor rotten

| Repair Item | Priority | Repair Description |
|---|---|---|
| 1 | High | replace deck, missing delineators and bridge ahead signs |

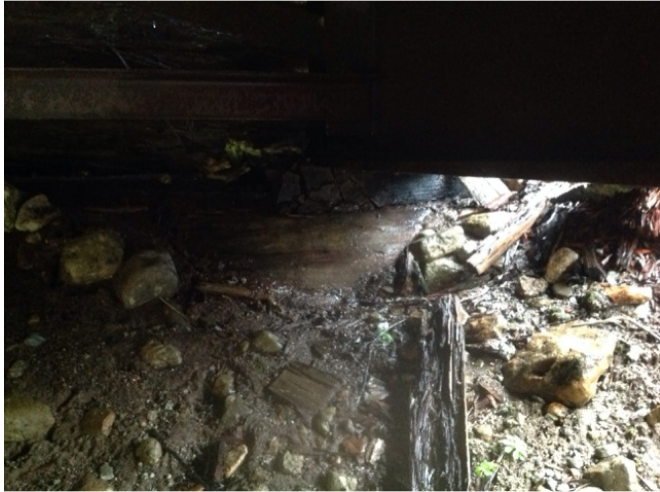
Caps or Sills Fair single log sills, left bank has timber shims that are rotten and crushing

Bearings Fair poor on left. bank due to rotten shims

lefty bank timber planks crushing on sill

| Repair Item | Priority | Repair Description |
|---|---|---|
| 2 | High | remove and replace rotten sill shims on left bank |
