CK-2359

STAVE RIVER 12km

2014 Inspection

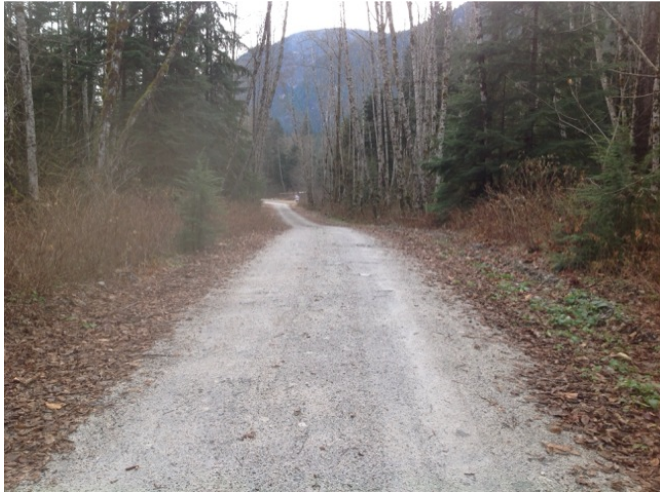
Approach from Right Bank when facing downstream

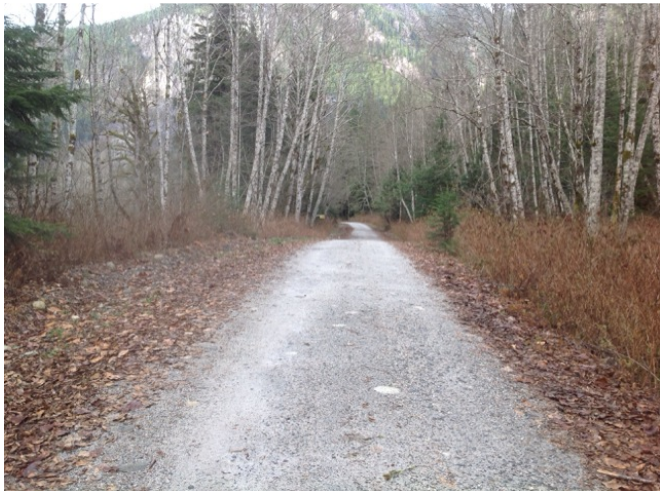
Approach from Left Bank when facing downstream

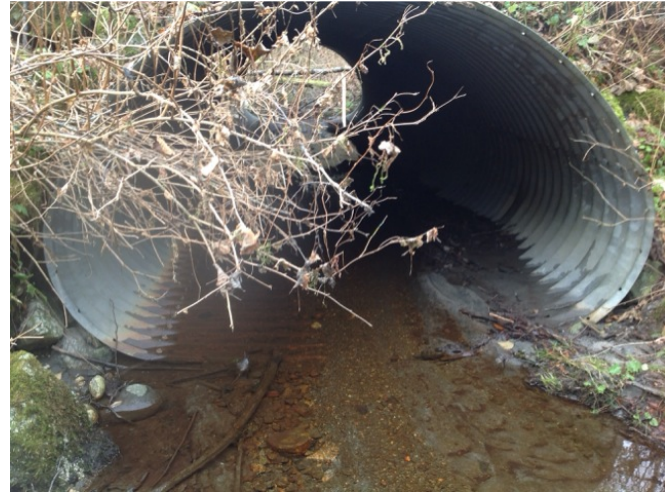
Inlet Good

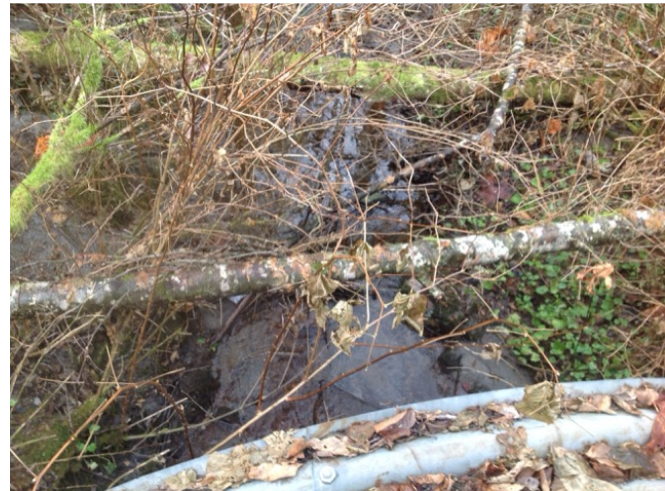
Outlet Good
