CK-2360

KOOKIPI SEVEN 4.2km

2014 Inspection

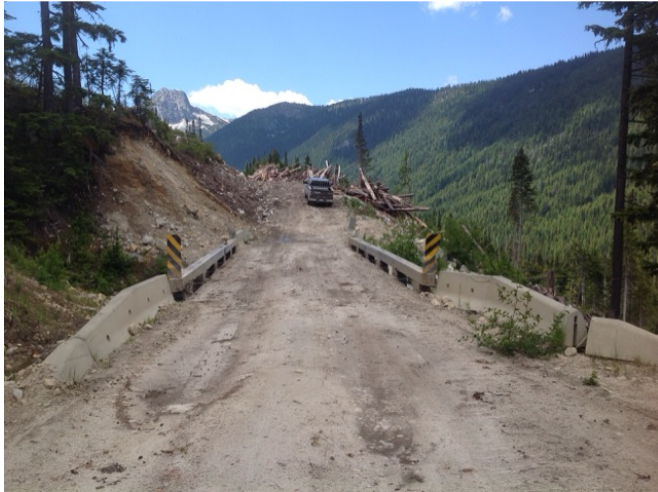
Approach from Right Bank when facing downstream

Bridge Ahead Signs  
Missing ☐ 0 ☐ 1 ☒ 2

| Repair Item | Priority | Repair Description |
|---|---|---|
| 1 | Medium | post bridge ahead signs |

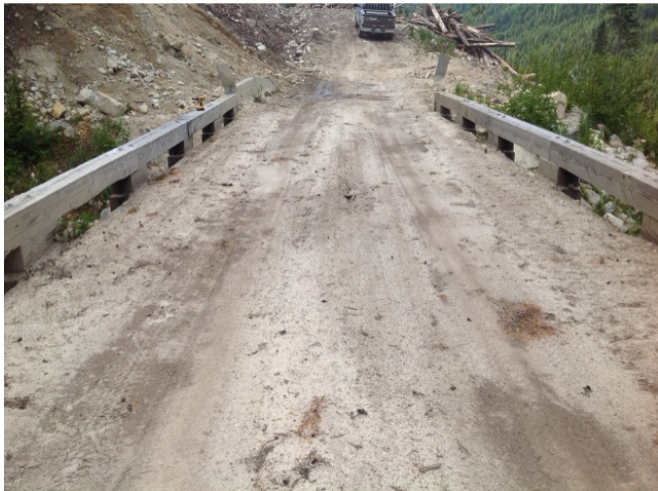
| Running Surface | Fair | lots of sediment on deck |
| Overall Deck Condition | Poor | due to sediment and guardrail |

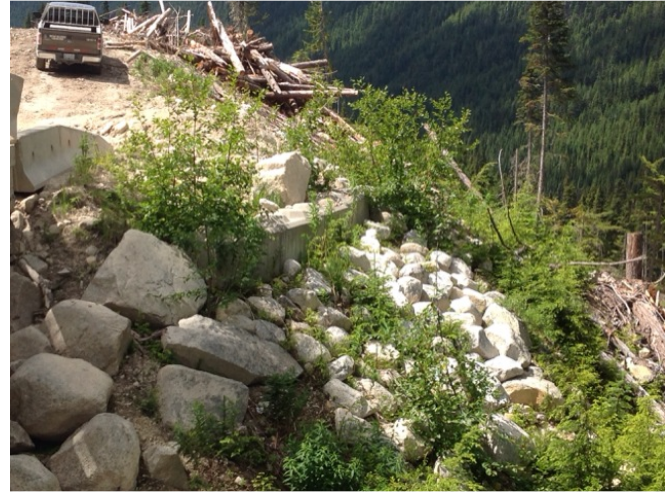
left bank wing wall

Wing WallBracing Fair lock blocks retaining some fill both ends downstream

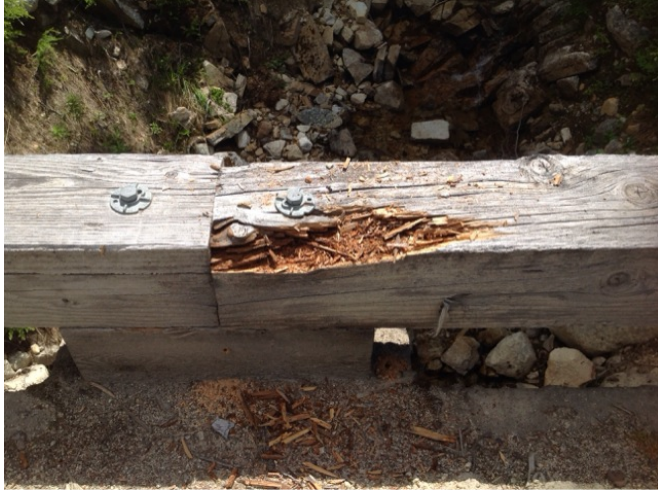
| Curb Rail/Blocks/Posts | Poor | rotten |
| Hardware | Poor | loose rail bolts |

rotting guardrail

Replace guardrail, risers and blocks. Post bridge ahead signs. Present load rating of L75 or 68 tonnes to continue.

| Repair Item | Priority | Repair Description |
|---|---|---|
| 2 | Medium | replace guardrail, risers and blocks |
