CK-2361

KOOKIPI SEVEN 5.27km

2014 Inspection

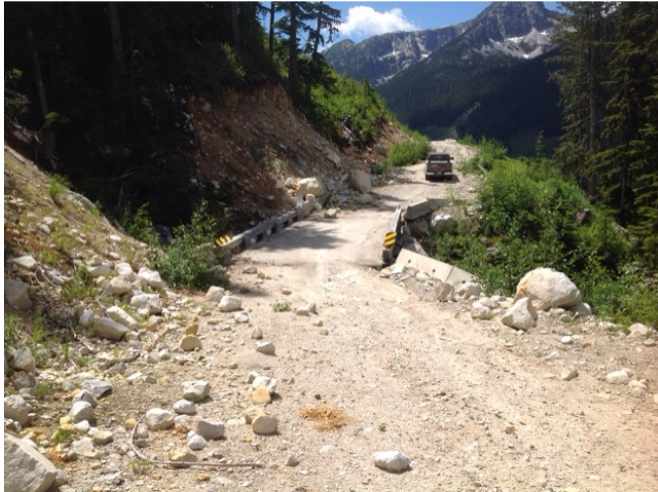
Approach from Right Bank when facing downstream

Road Surface Poor debris/rock on approaches

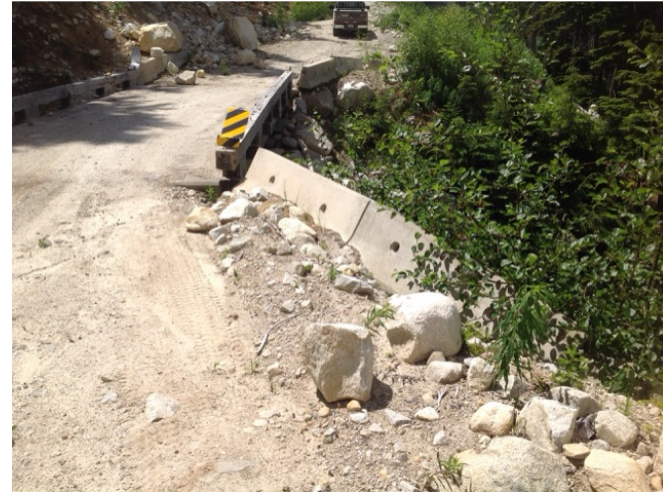
Fill Poor eroding on all 4 corners

no post barriers

| Repair Item | Priority | Repair Description |
|---|---|---|
| 1 | Medium | repair fill on all 4 corners and reset no post barriers |

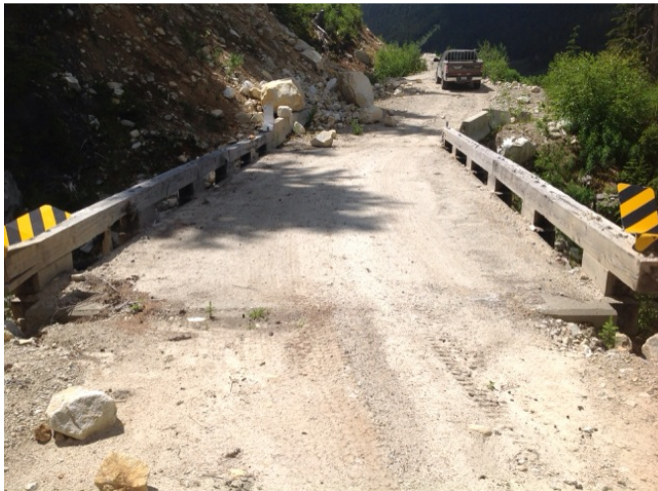
| Running Surface | Fair | sediment on deck |
| Curb Rail/Blocks/Posts | Poor | rotten |
| Hardware | Poor | loose rail |
| Overall Deck Condition | Poor | due to rail |

| Repair Item | Priority | Repair Description |
|---|---|---|
| 3 | Medium | replace guardrail, risers and blocks |
