CK-2362

KOOKIPI SEVEN 6.5km

2014 Inspection

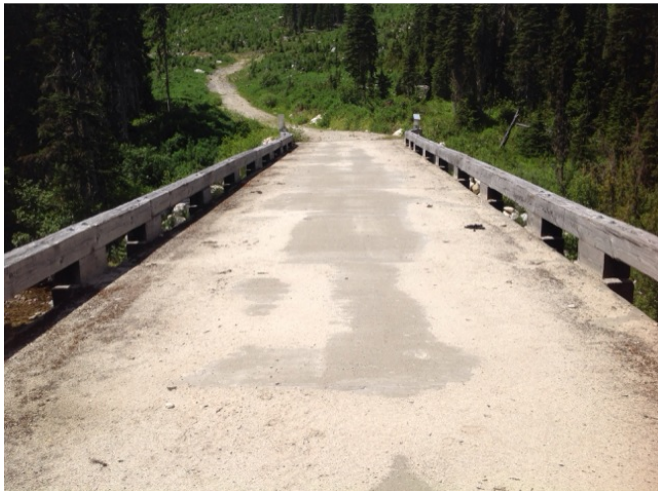
Deck

| Running Surface | Fair | 10 panels, flared both approaches |

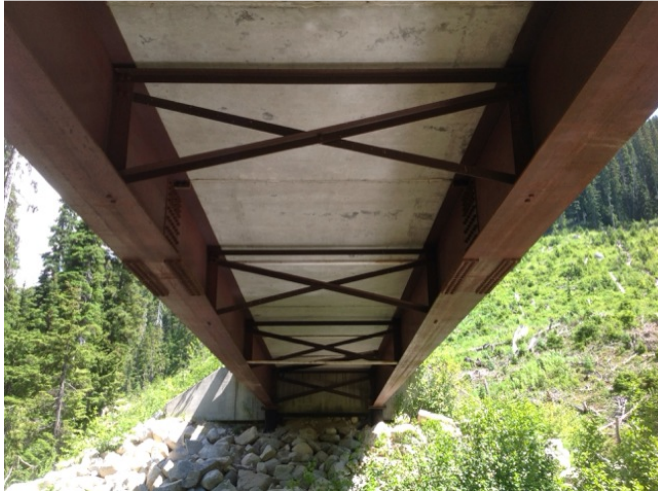
superstructure

Girders Good steel I beams, spliced

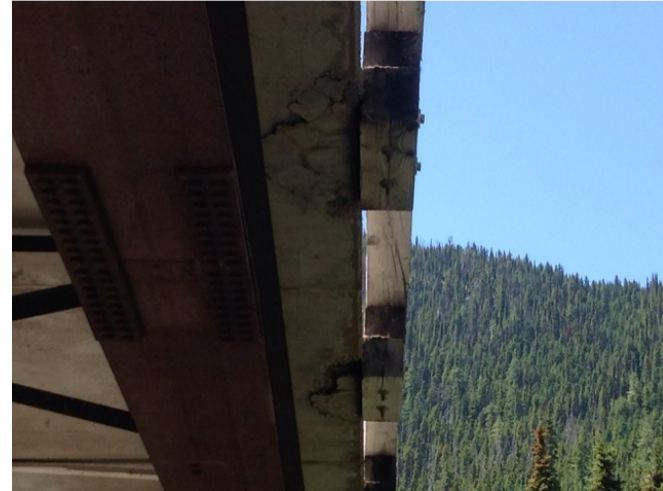
Road is deactivated just before the structure. Replace guardrail, risers and blocks and post bridge ahead signs when active. Monitor deck panels 6 and 7. Present load rating of L75 or 68 tonnes to continue.

| Concrete Deck | Fair | panels 6 and 7 have sustained damage (see photo) |

panels 6 and 7

1 panels 6 and 7
