CK-2364

CONNOR CREEK 0.05km

2014 Inspection

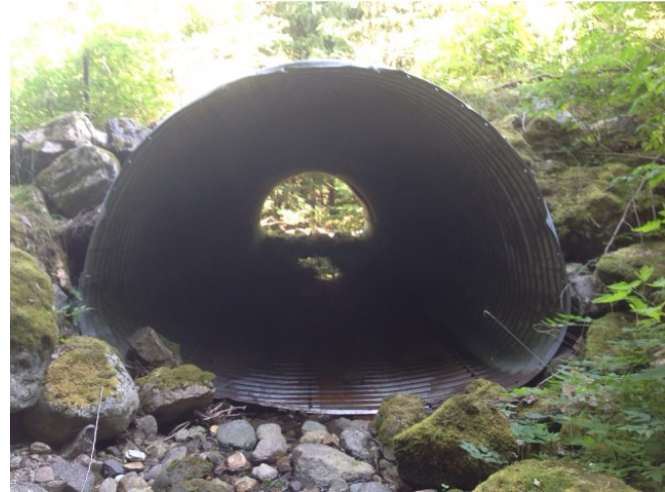
Inlet Good

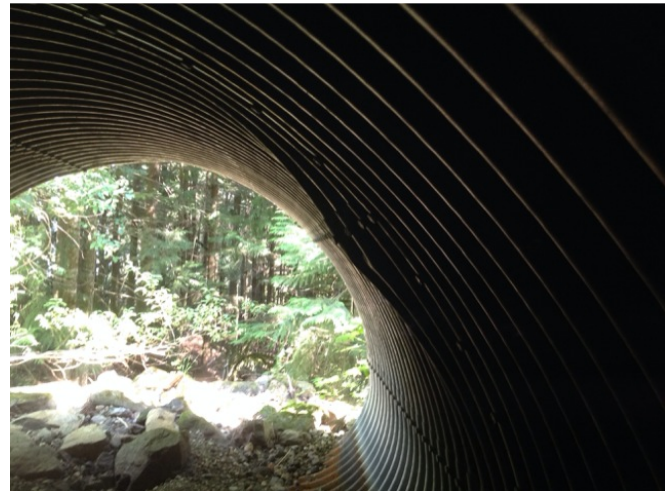
Sidewalls Fair small damage noted

inside minor damage

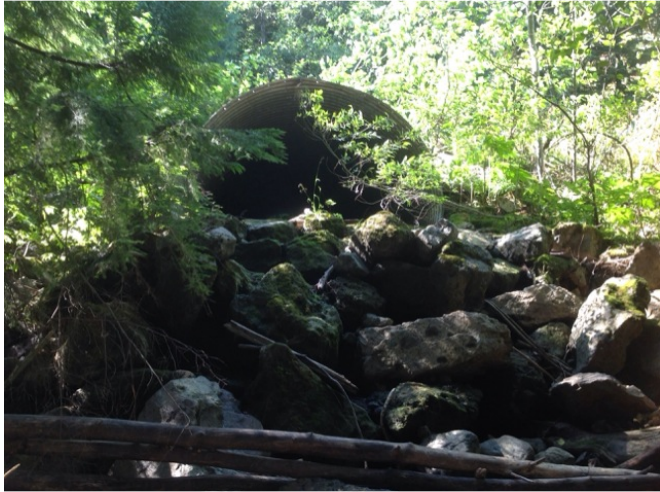
Outlet Good well riprapped
