CK-2366

STAVE RIVER 15.6km

2014 Inspection

Structure Class Major Culvert

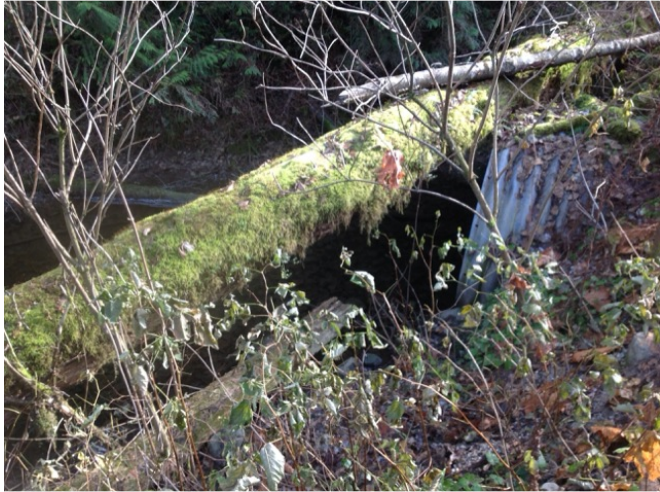
Inlet Good

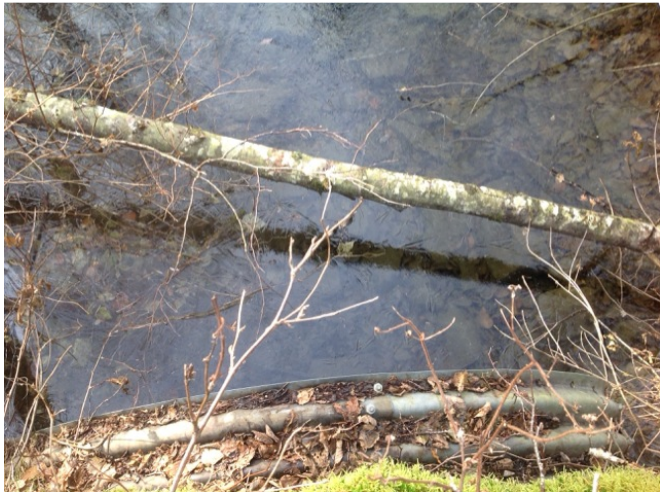
Outlet Good
