CK-2367

STAVE RIVER 19.1km

2014 Inspection

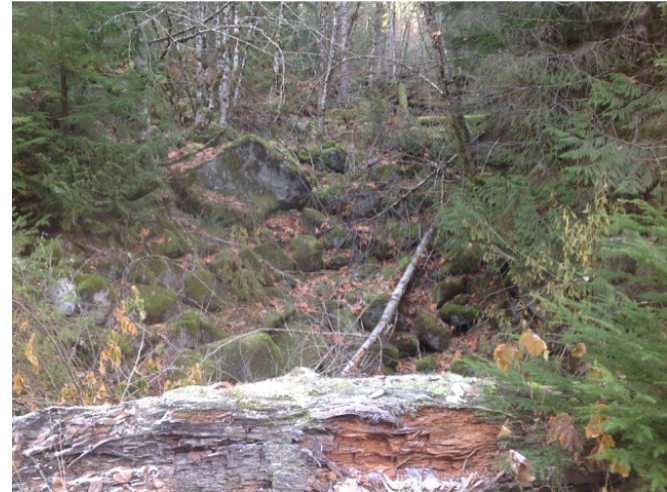
Inlet Fair steep stream grade upstream

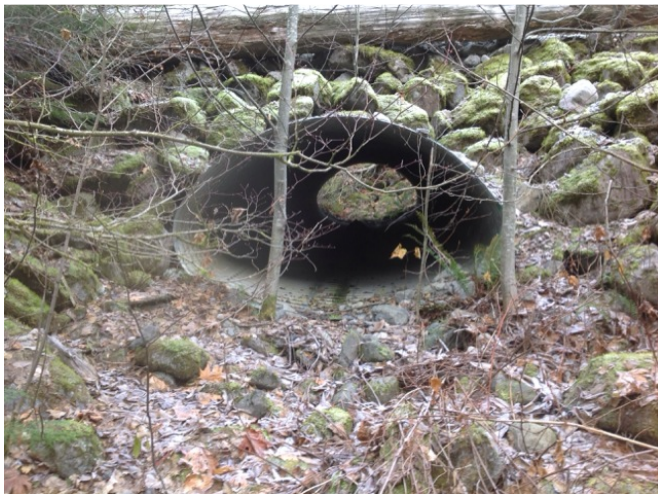
Outlet Fair
