CK-2368

KAREN CREEK 0.17km

2014 Inspection

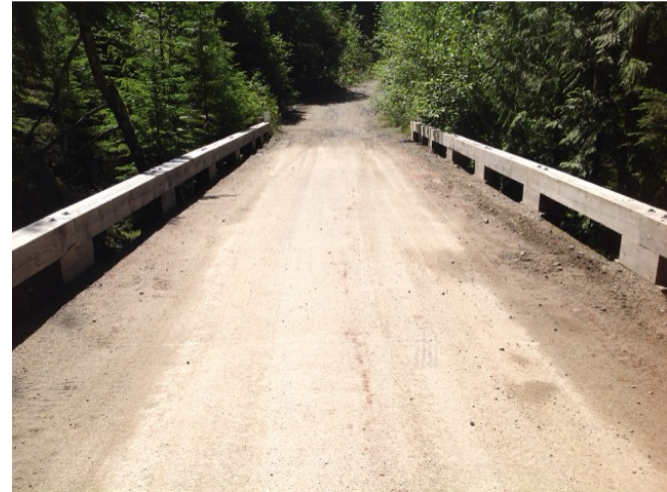
Concrete Deck      Good      8 panels, flared right approach

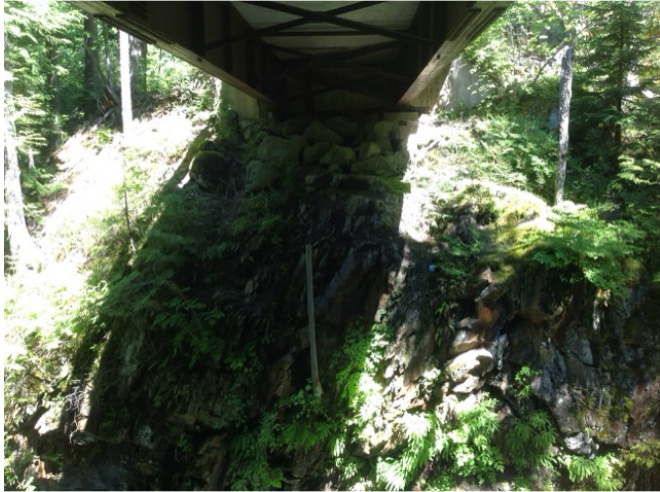
Right Bank Abutment when facing downstream

Piles or Posts Good CIP right bank, buried left bank

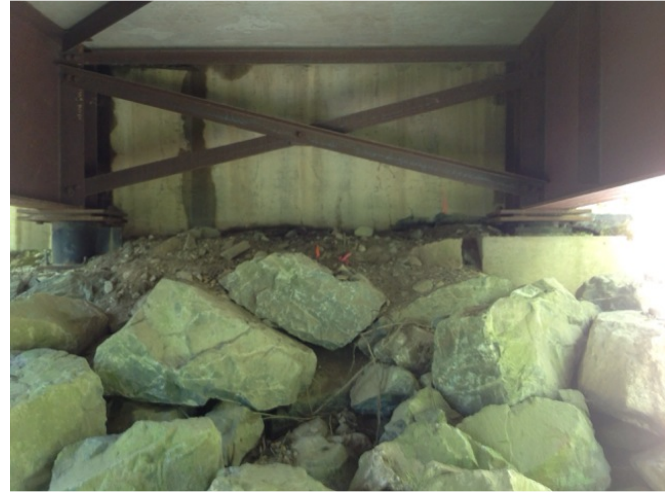
right bank bearing

Bearings Good

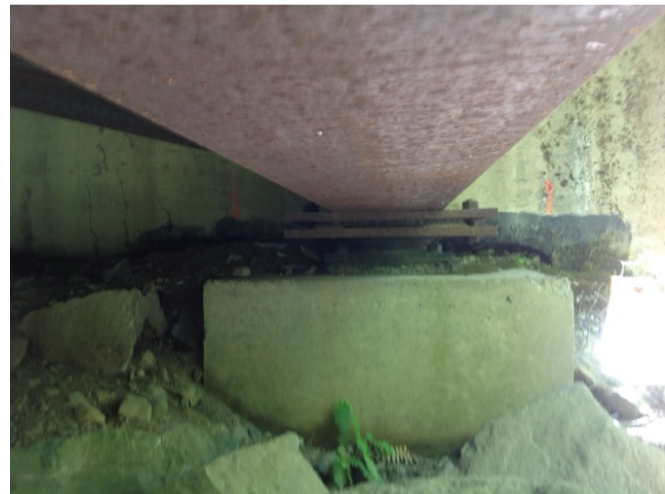
right upstream

Comment debris accumulations noted upstream - lots of clearance to flush
