CK-2372

SOWERBY CREEK 1.6km

2014 Inspection

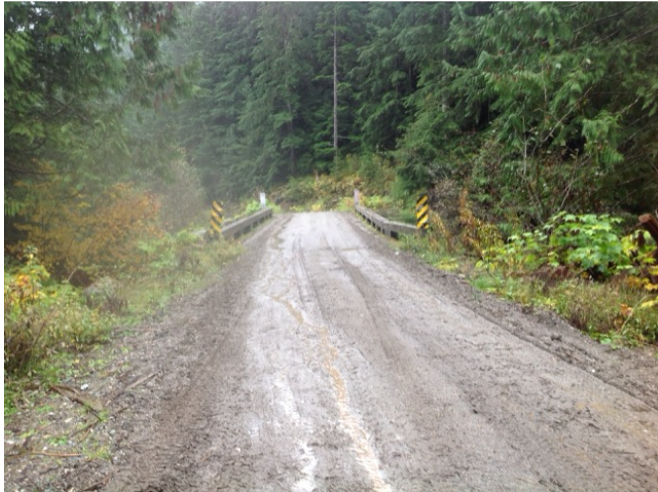
Approach from Left Bank when facing downstream

HC both approaches

Bridge Ahead Signs  
Missing ☐ 0 ☐ 1 ☒ 2

Fender Condition Poor

Replace guardrail, risers and blocks. Post bridge ahead signs and place fenders or concrete no post barriers at both approaches. Present load rating of L75 or 68 tonnes to continue.

| Repair Item | Priority | Repair Description |
|---|---|---|
| 1 | Medium | post bridge ahead signs |

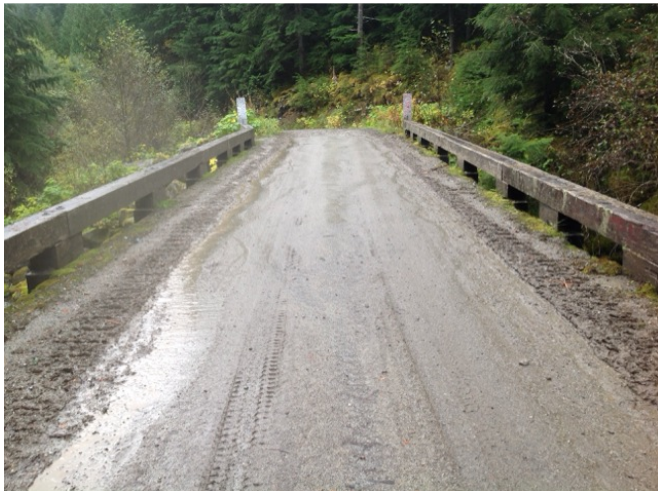
Concrete Deck    Fair    flared upstream left approach, and downstream right approach

Curb Rail/Blocks/Posts    Poor    rotten risers and blocks

Hardware    Poor    loose rail bolts

Overall Deck Condition    Poor    due to rail

| Repair Item | Priority | Repair Description |
|---|---|---|
| 2 | Medium | replace guardrail, risers and blocks |
