CK-2378

STAVE RIVER 8.8km

2014 Inspection

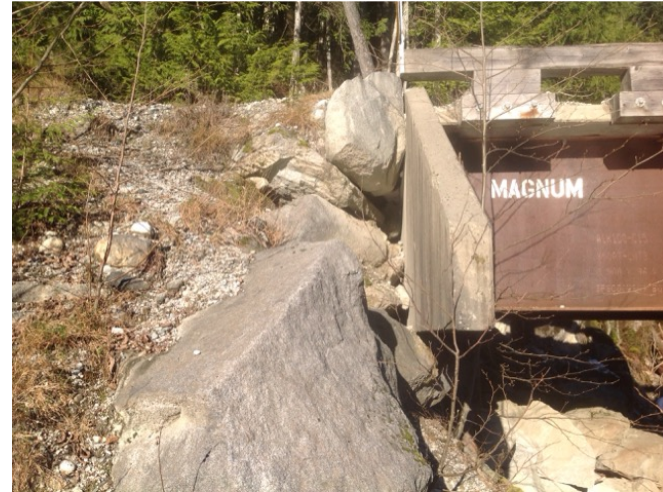
Fill Poor downstream right approach failing

eroded fill right downstream approach

| Repair Item | Priority | Repair Description |
|---|---|---|
| 3 | Medium | replace missing fill and no posts on downstream right approach |

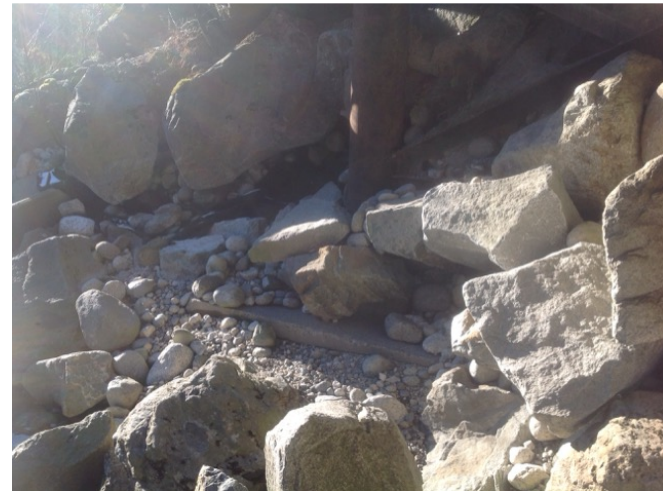
At present the right downstream footing pad is exposed and not protected from future scour. The stream thalweg is approximately 1.5m below footing pad elevation in this location and as such very susceptible to scour. Replace missing riprap in front of downstream right abutment ASAP along with the associated road fill, and replace no post barriers. Repair/grout over exposed rebar at top right ballast wall.

Riprap Poor only poor downstream right abutment - scoured away leaving pad exposed

scoured right downstream footing

| Repair Item | Priority | Repair Description |
|---|---|---|
| 1 | High | replace missing riprap in front of downstream right abutment, repair top right ballast wall |

| 1 | scour at right abutment | Anually |

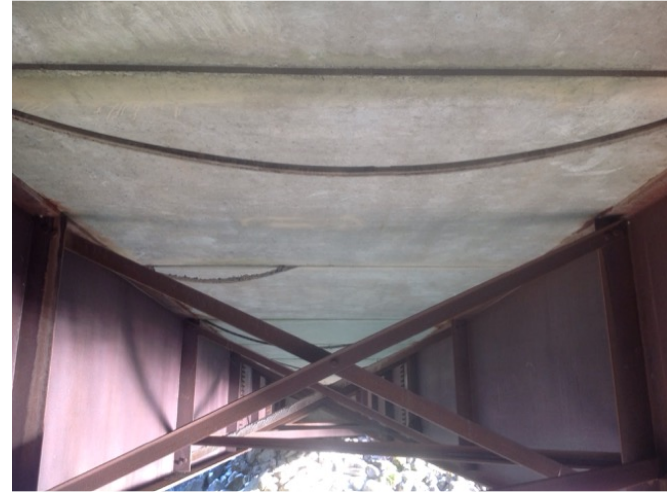
Deck Joints Fair all deck seals have either fell out or falling out

rubber deck seals falling out

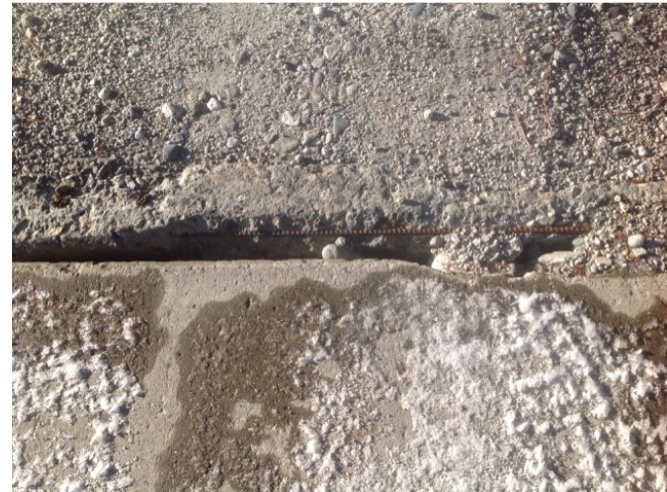
Ballast Wall Fair damage noted on top of right wall

right ballast wall damage

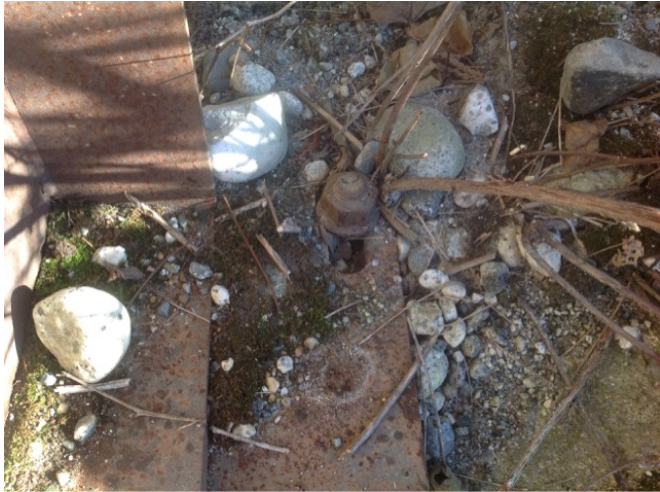
left bearing bolts at far end of slot

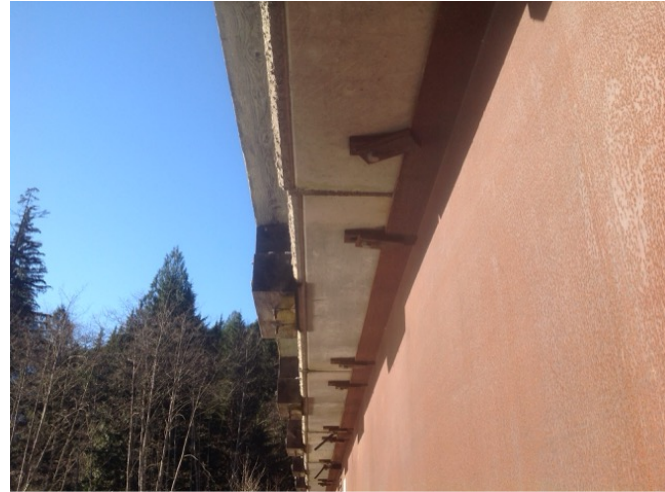
downstream deck clips

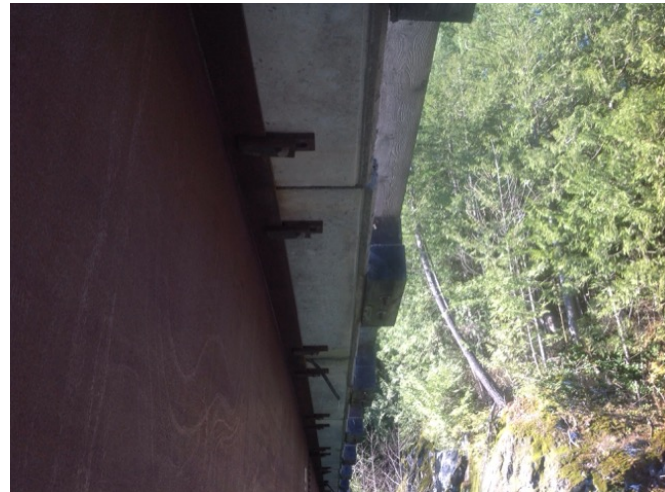
upstream deck clips

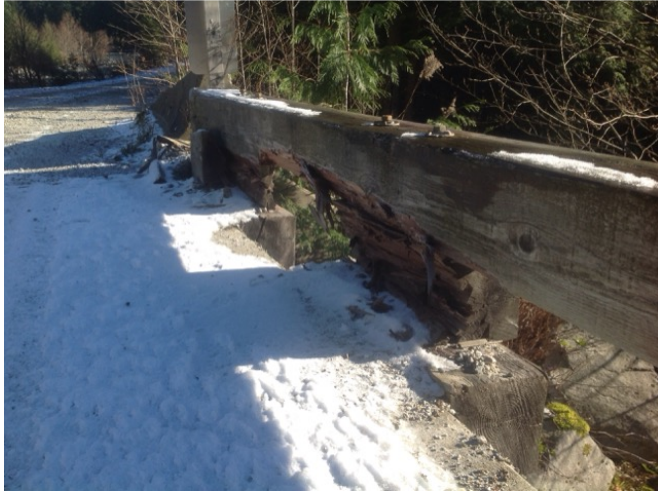
Curb Rail/Blocks/Posts Fair some damage noted

damaged guardrail

| Repair Item | Priority | Repair Description |
|---|---|---|
| 2 | Medium | replace damaged guardrail and post bridge ahead signs |
