CK-2386

CENTRE CREEK 5.1km

2014 Inspection

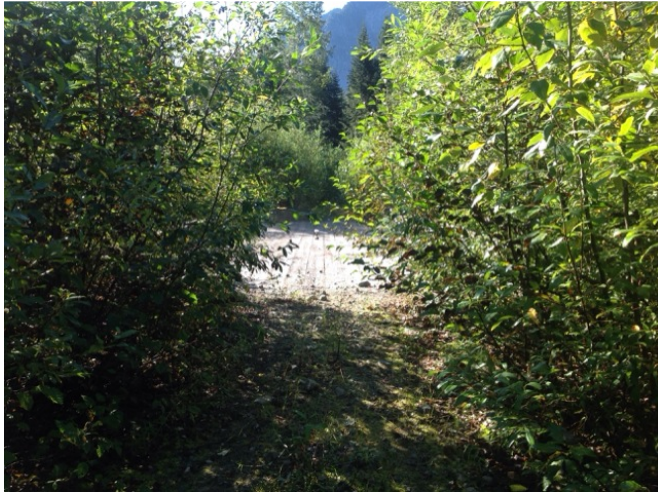
Approach from Left Bank when facing downstream

Road Surface Poor overgrown

| Repair Item | Priority | Repair Description |
|---|---|---|
| 3 | Medium | brush with activity |

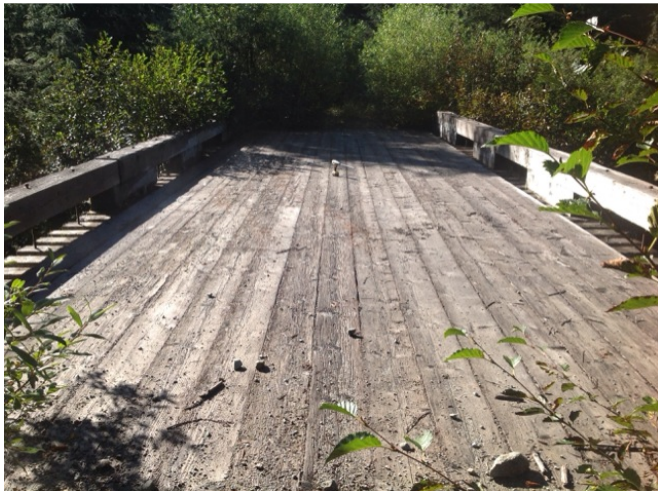
Running Planks Poor rotting

Ties Poor rotting

Curb Rail/Blocks/Posts Poor loose rail, rotting risers

Overall Deck Condition Poor replace deck

| Repair Item | Priority | Repair Description |
|---|---|---|
| 1 | High | replace deck prior to activity |

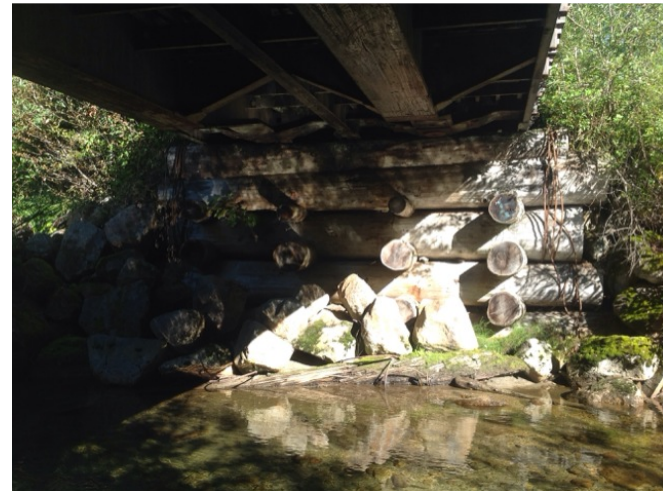
Left Bank Abutment when facing downstream

Caps or Sills Fair left abutment has log sill placed on top of crib, cut flat and lashed to crib

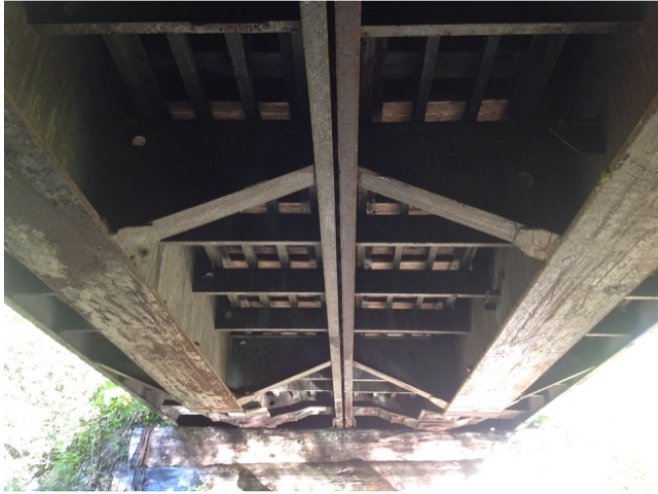
superstructure

Girders Fair 2 railcars

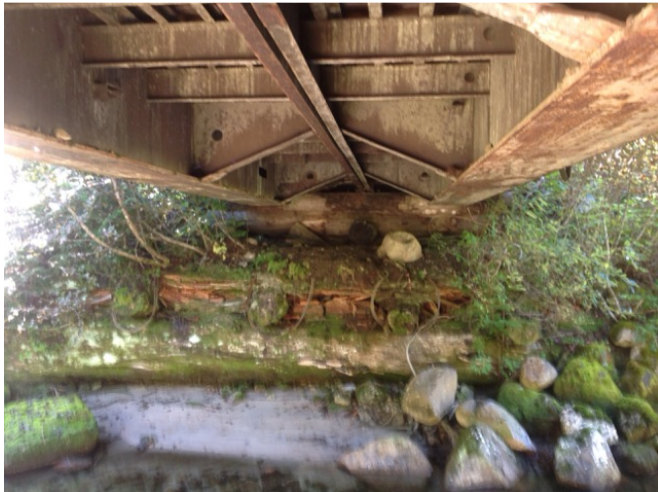
Right Bank Abutment when facing downstream

Log/Timber Cribs Fair old crib on right bank just retaining fill in poor shape especially upstream end - bearing crib has some rot

| 1 | old crib on right bank just retaining fill | routine inspection |
